HUNTER WATER

SECTION s170 REGISTER

North Lambton 1 Reservoir

ITEM DETAILS

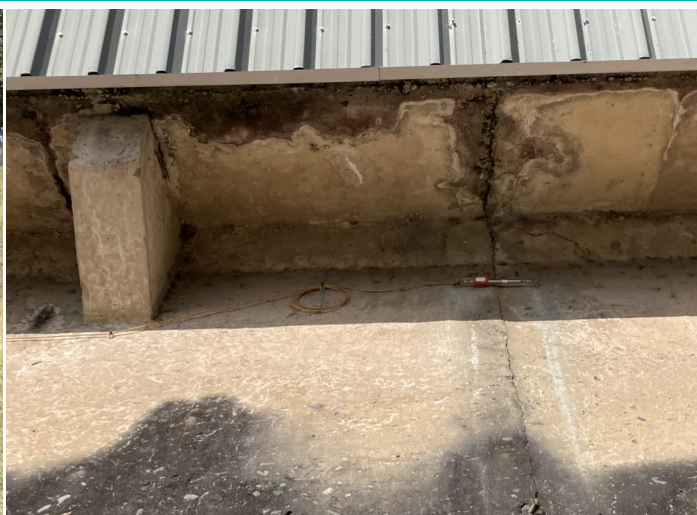
Image 4: Evidence of concrete failure and damage caused by moisture to the soffit and wall of the Reservoir

Priority Conservation Works	<ul style="list-style-type: none"> • Maintain overall form, shape and scale of the reservoir and valve house (including annex). • Assess all evidence of concrete failure and/or spalling, as well as issues caused by moisture. Repair where necessary.

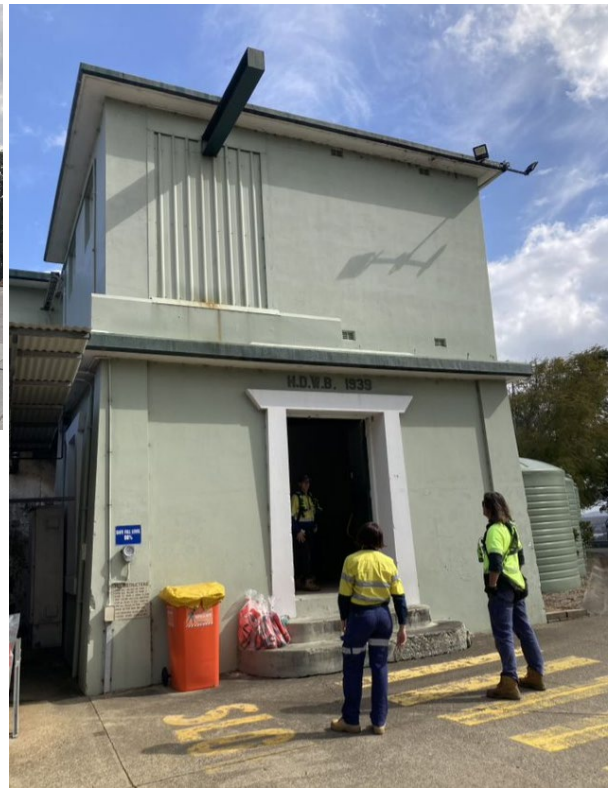
<p>A drainage channel lined in geofabric partially surrounds the reservoir and a concrete driveway runs along the western and north-eastern sides of the reservoir.</p> <p>The site is surrounded by metal security fencing. A chemical dosing facility, which is recent and non-significant, is located immediately adjacent to both the Reservoir and valve house. A contemporary (non-significant) brick site office and associated demountable building is located to the north-eastern elevation of the reservoir.</p> <p>There are a number of recent and non-significant buildings and structures within the allotment (to the north of the Reservoir), but outside of the defined heritage curtilage for this item.</p> <p>Several condition issues have been identified including:</p> <ul style="list-style-type: none"> • Evidence of spalling and concrete failure to soffit of reservoir. • General evidence of fabric deterioration to the reservoir caused by damp. • Spalling/concrete failure to curved entry steps of valve house.

Image 6: Northern elevation of the main valve house showing curved concrete stairs, boarded up opening with gantry and rendered detailing to the entry way

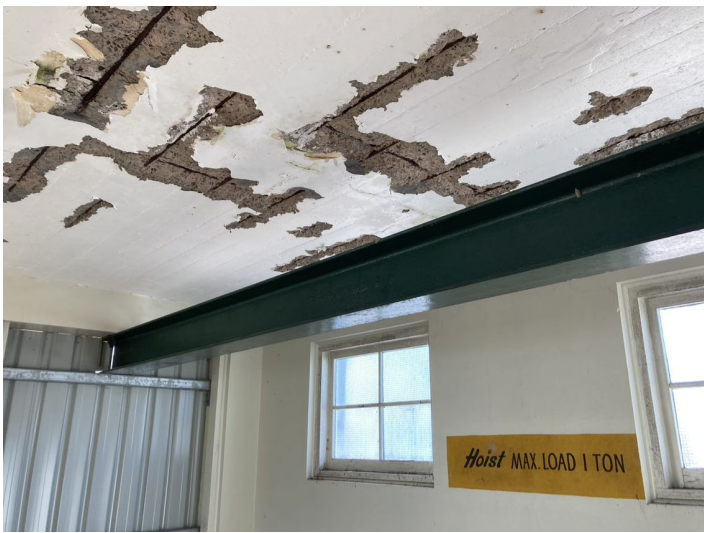
Internal Appearance	<p><u>Valve House:</u> internal walls are rendered and painted brickwork, with original timber floorboards present. Concrete flooring is also present. The ceiling is painted concrete showing evidence of spalling. Doors have been replaced with flush doors. Original painted signage is present within the main valve house.</p> <p><u>Annex:</u> exposed brick walls, with an unpainted concrete ceiling. The floor is concrete.</p> <p><u>Reservoir:</u> N/A (internal inspection not undertaken).</p>
Overall Condition	Good
Moveable Heritage Objects	None identified.

Image 9: Original windows, gantry, ceiling and signage within the main valve house

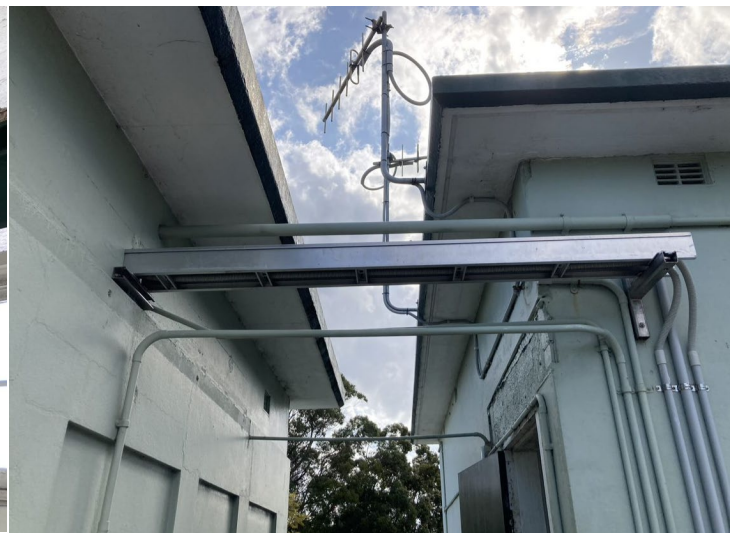
Image 10: Interface between the main valve house (right) and annex (left) showing contemporary services
