HUNTER WATER

SECTION s170 REGISTER

Tarro Valve House – Anderson Drive

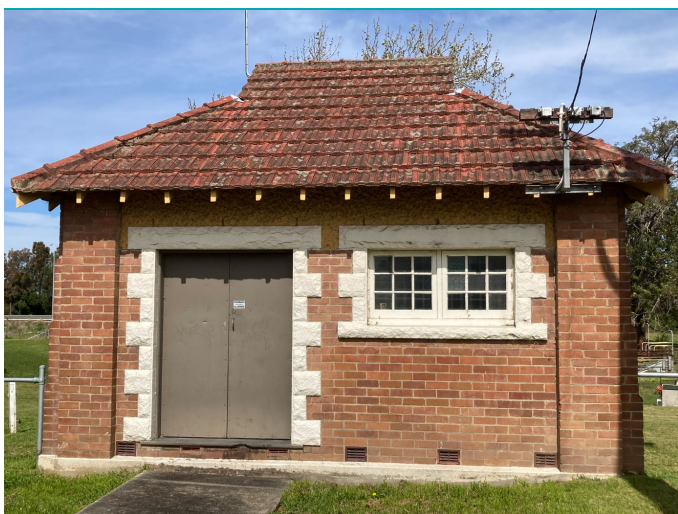
View of the principal (northern) elevation of the Valve House

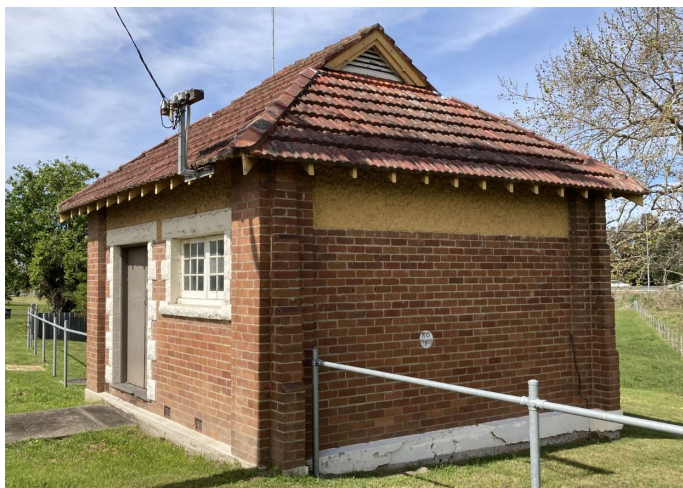
Image 1: View of the northwestern corner of the building showing concrete failure to the western footing

Priority Conservation Works	<ul style="list-style-type: none"> Assess concrete and stone condition (particularly to western elevation footings) and repair as necessary. Re-point brickwork as required. Investigate and repair damage to threshold.

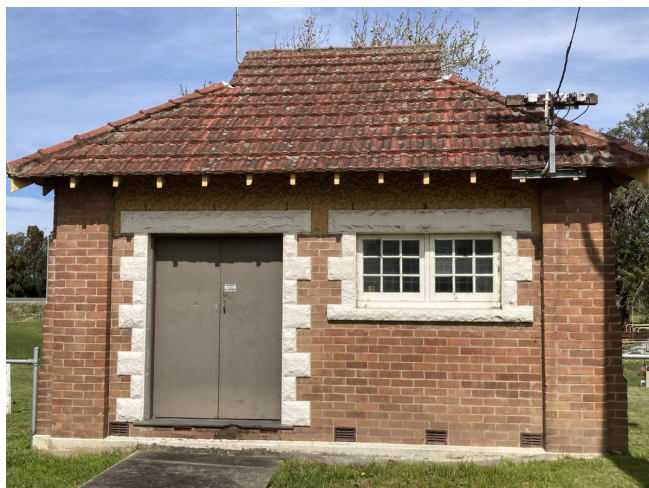
Image 2: View of the principal (northern) elevation showing decorative quoins to openings

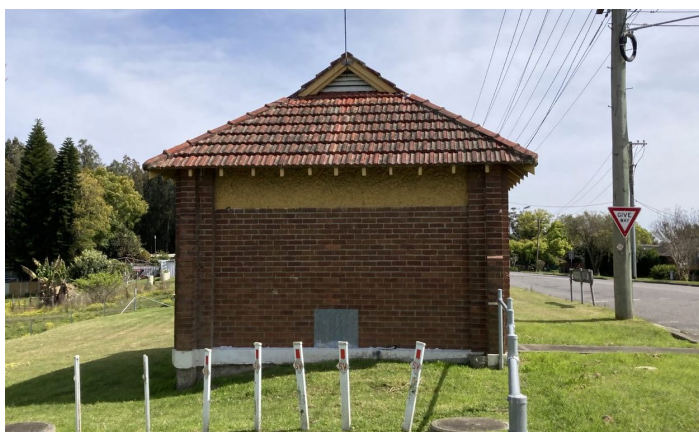
Image 3: View of the eastern elevation of the building showing timber vents

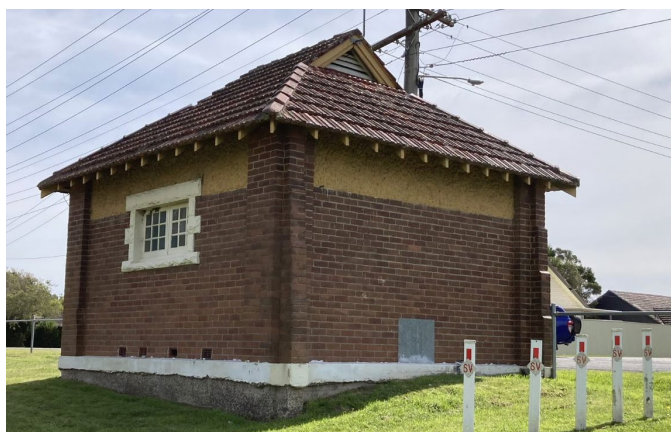
Image 4: View of the rear (southern) elevation showing timber windows with decorative quoins to opening and terracotta vents
