HUNTER WATER

SECTION s170 REGISTER

Teralba 1 Water Pump Station

ITEM DETAILS

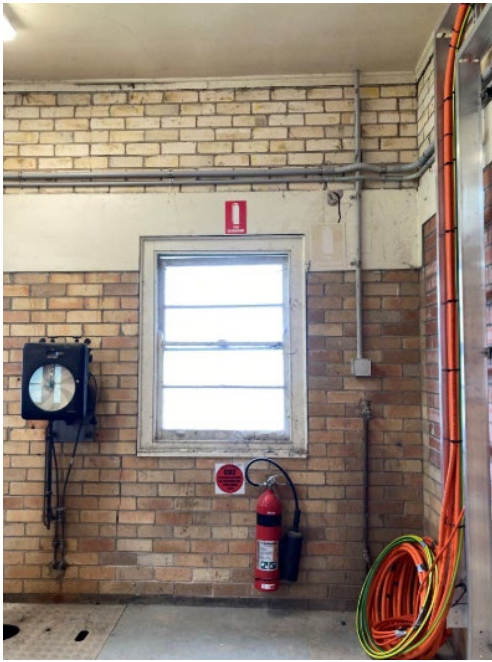
Image 7: Timber sash window

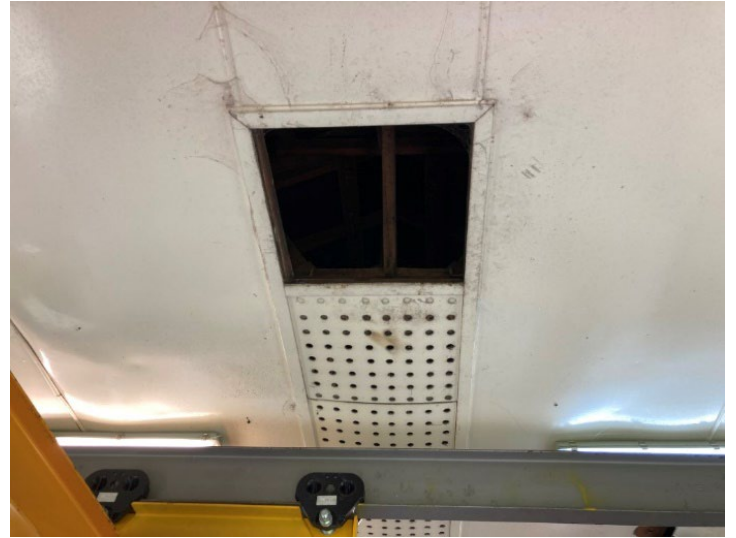
Image 8: Ceiling panels showing missing panel

Priority Conservation Works	<ul style="list-style-type: none"> Assess and repair damage to external brickwork and concrete render, including mortar loss, spalling, and cracking. Assess and repair damage to internal concrete slab floor, including sealing, salt accumulation, and spalling. Assess and repair damage to timber joinery, including windows and doors. Repair damage to ceiling panels.
