HUNTER WATER SECTION s170 REGISTER

Carrington 2 Wastewater Pump Station

Item Name	Carrington 2 Wastewater Pump Station
Other / Former Names	N/A
NSW SHI No.	3630060
GID	272827
Plant No.	SS-CAN-002-PS1
Local Government Area	Newcastle
Lot and DP	Lot 1 DP 1075747
Address	2A Victoria Street, Carrington NSW 2294
Curtilage	The curtilage of this asset is defined by its legal allotment boundaries (defined by the relevant Lot and DP).

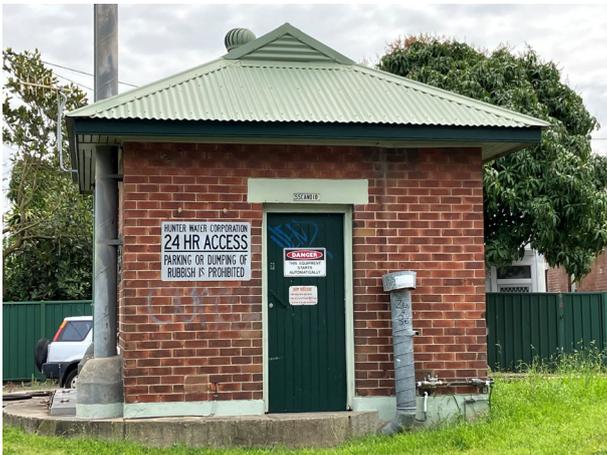
Image 1: Entrance

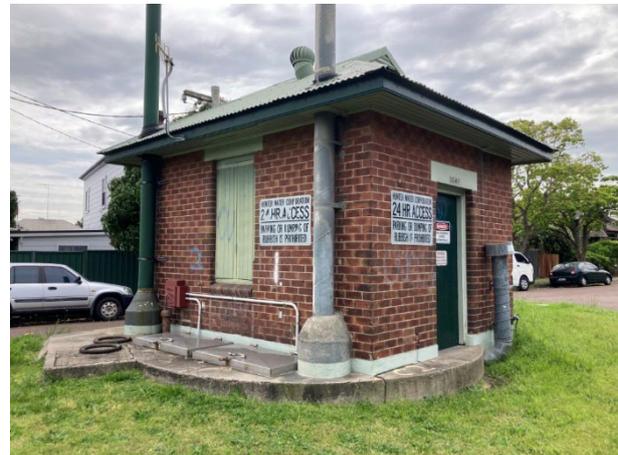
Image 2: Angled concrete footings to accommodation subsurface services

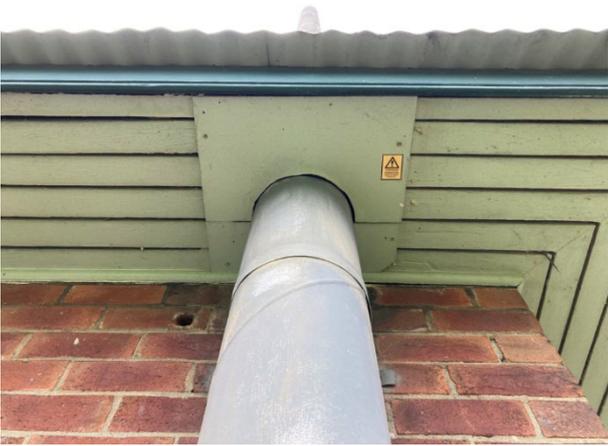
Image 3: Timber panel soffit

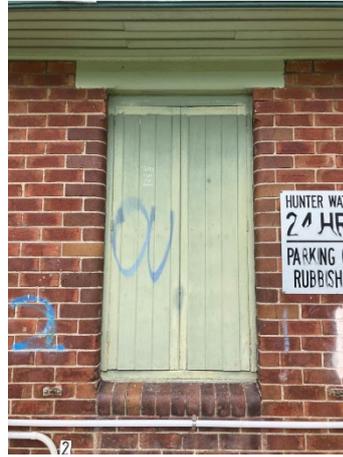
Image 4: Window shutters

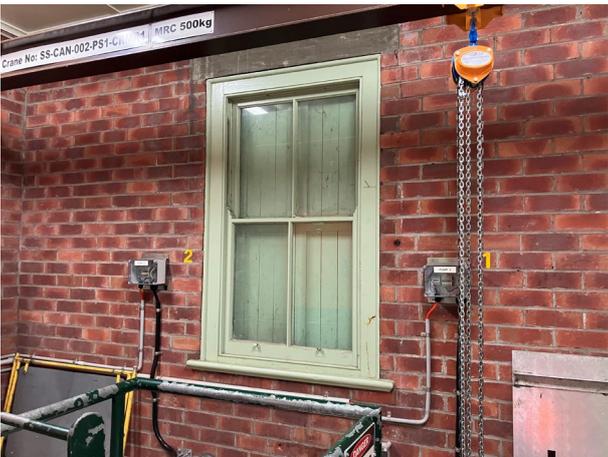
Image 5: Timber sash window

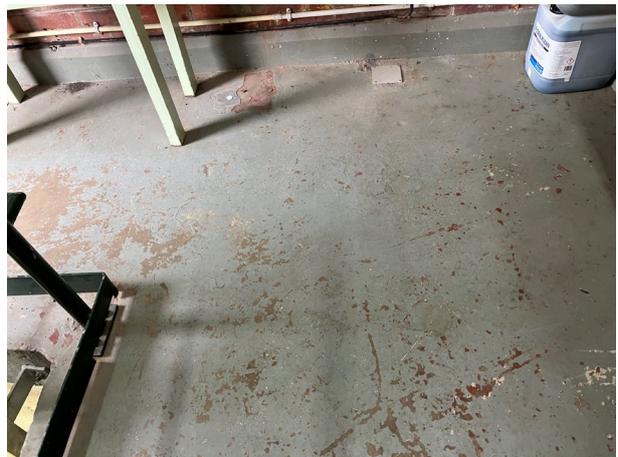
Internal Appearance	The building comprises of a single room. The floor is a concrete slab with an eroding sealant layer. The internal brickwork face has been left exposed. The centre of the space is dominated by a dry well and associated machinery lines the walls. A steel overhead crane beam runs the length of the building and is supported by stepped bricks projecting from the wall. The ceiling consists of cream-painted panels.
Overall Condition	Fair.
Moveable Heritage Objects	None identified.

Image 6: Eroding sealant layer on floor

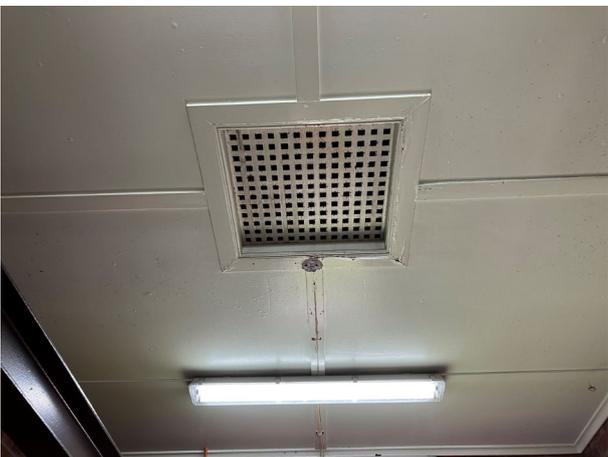
Image 7: Ceiling panels

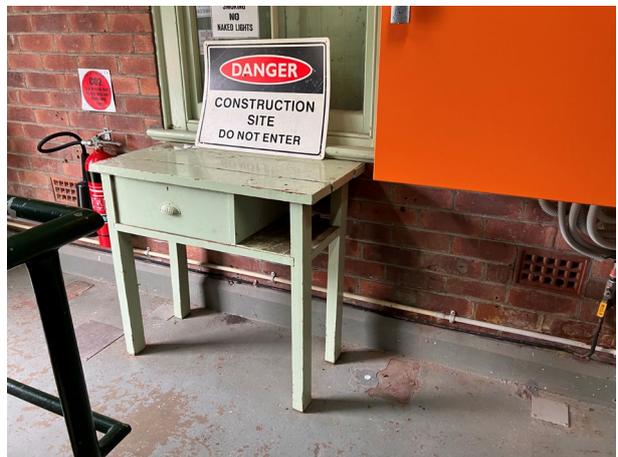
Image 8: Internal view of floor and wall within the Station
