HUNTER WATER

SECTION s170 REGISTER

Toronto 2 Wastewater Pump Station

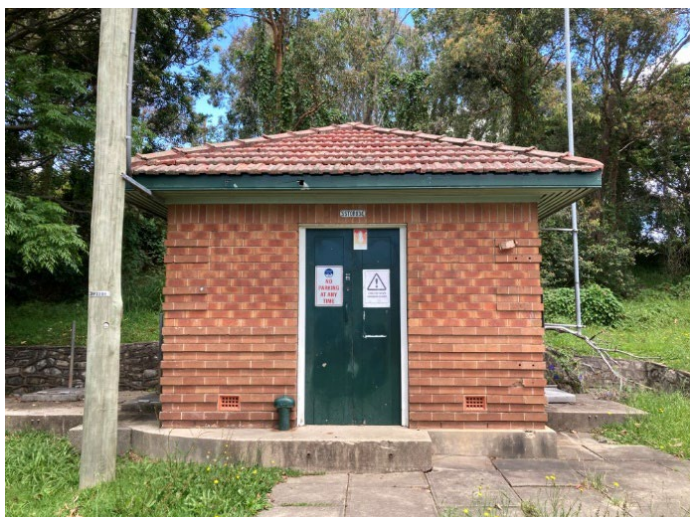
Image 1: Entrance

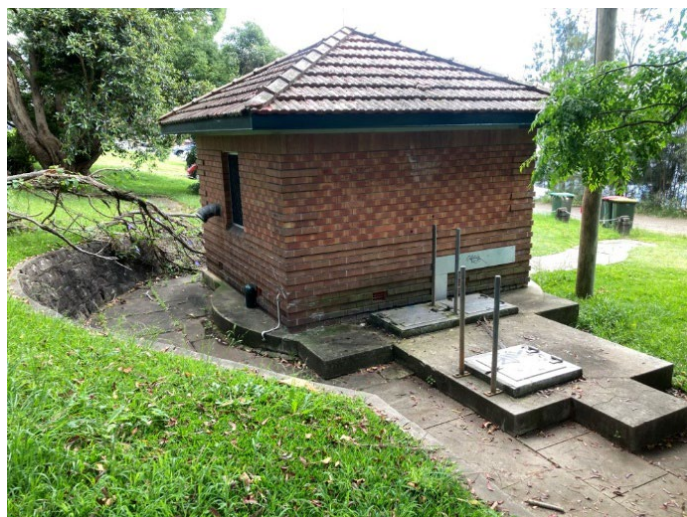
Image 2: Angled concrete footings to accommodate subsurface services

| Priority Conservation Works | <ul style="list-style-type: none"> Assess and repair damage to external brickwork and concrete foundations, including mortar loss, spalling, and cracking. |

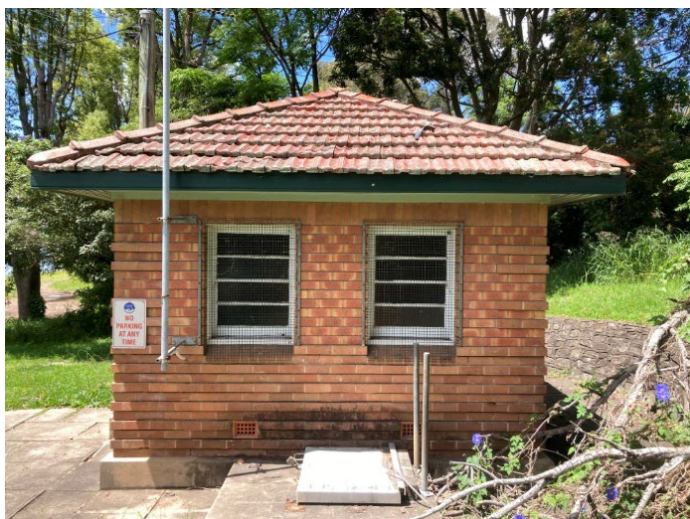
Image 3: Northern façade

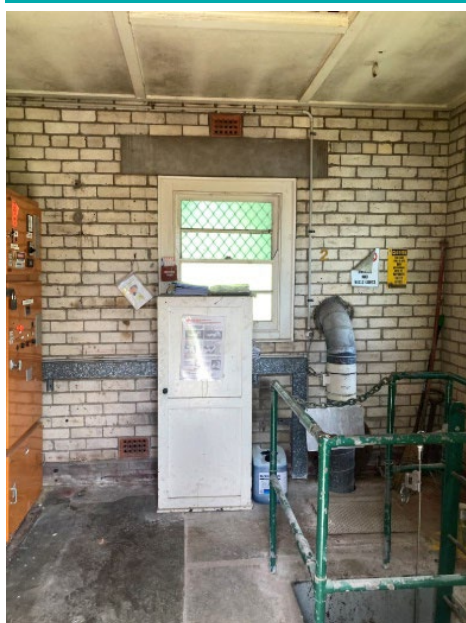
| Internal Appearance | <p>The building comprises of a single room. The floor is a sealed concrete slab. The internal brickwork face has been painted cream. The centre of the space is dominated by a dry well and associated machinery lines the walls. The ceiling consists of cream-painted panels.</p> |

Image 5: Internal space

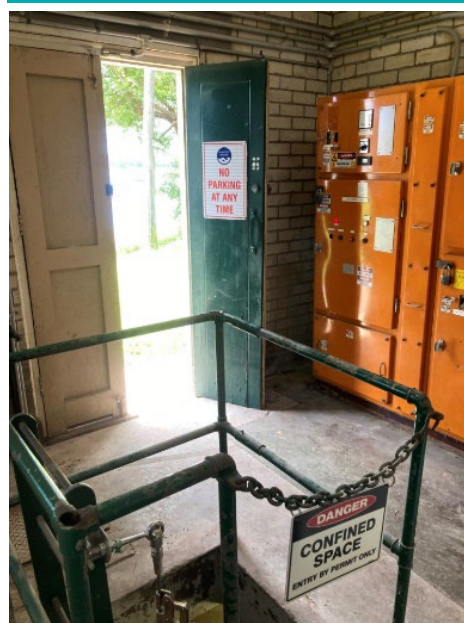
Image 6: Dry well and control panels
