HUNTER WATERSECTION s170 REGISTER

Chichester Dam Office

ITEM DETAILS

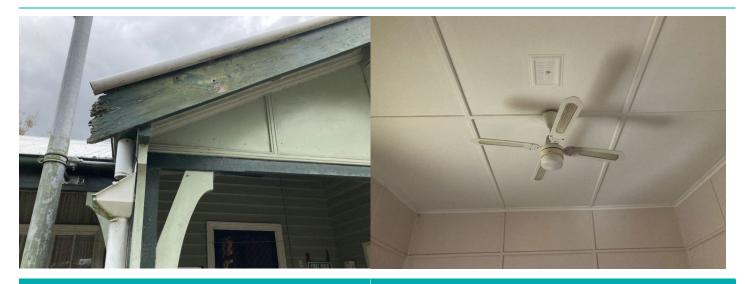
Image 5: Deteriorating timber and timber detailing to portico

- Assess timber condition (external) and replace/repair as needed.
- Re-paint all painted surfaces to ensure timber is maintained to an appropriate standard.
- Remove/rationalise modern services to interior and exterior of building where possible.
