# HUNTER WATER

## SECTION s170 REGISTER

## Bellbird Heights 1 Water Pump Station

### ITEM DETAILS

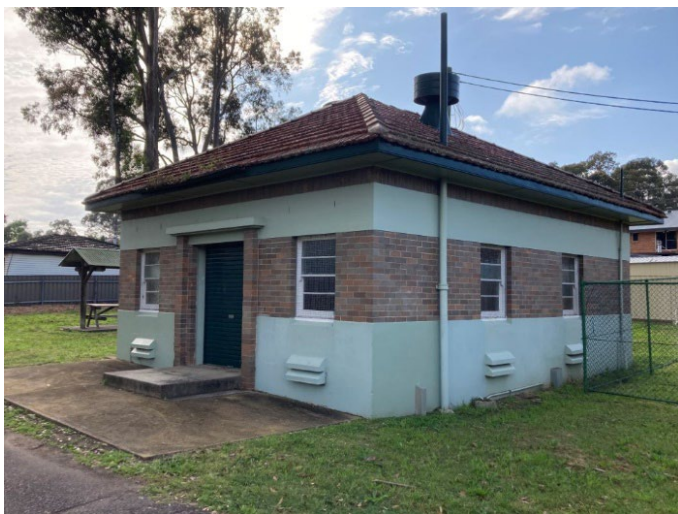
View of the exterior of the Pump Station

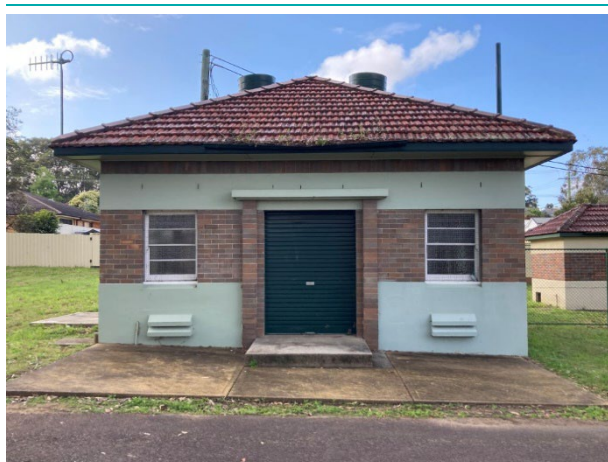
Image 1: Principal façade of the Pump Station

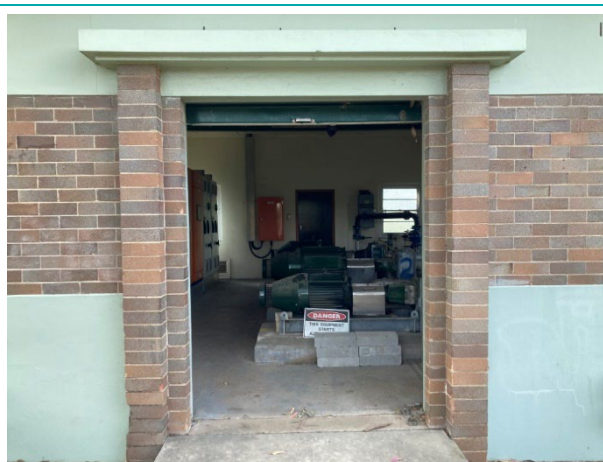
Image 2: Internal space

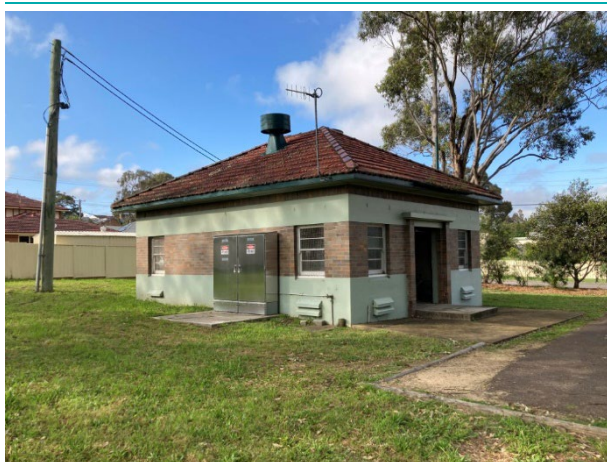
Image 3: Eastern façade

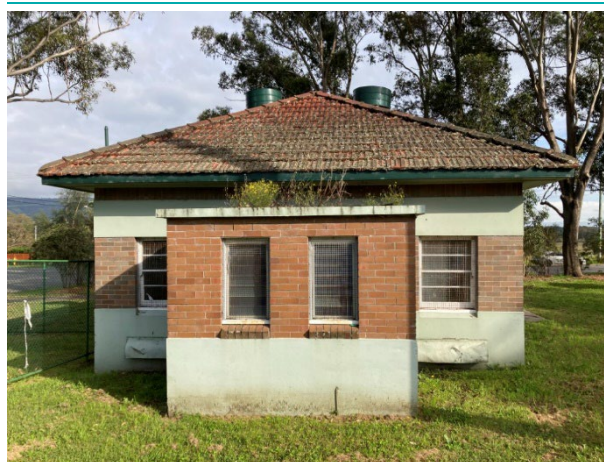
Image 4: Rear façade, showing rear bathroom extension

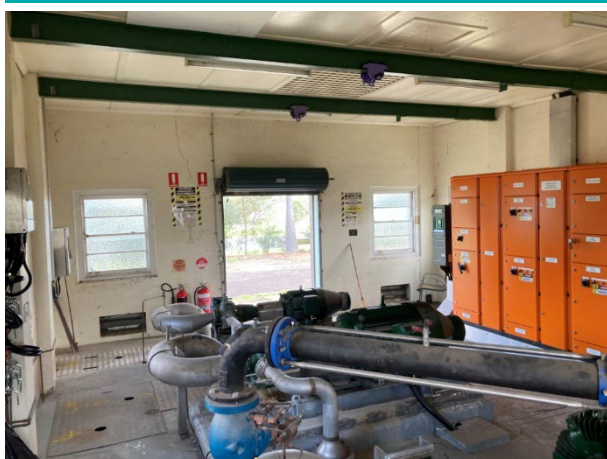
Image 5: Internal space, showing pump machinery and control panels
