HUNTER WATER

SECTION s170 REGISTER

Cardiff South 1 Water Pump Station

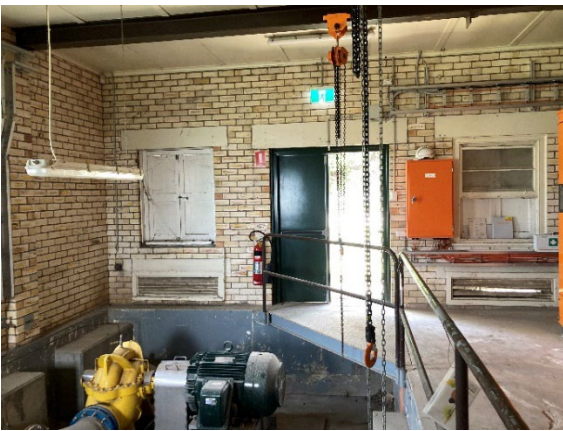
Image 3: Internal space, showing absent glazing in left window

Approval and Assessment Requirements	<p><u>Minor or inconsequential impacts:</u> Anything other than routine repair and maintenance must be discussed with the Environment Team to determine the level of heritage assessment required.</p> <p><u>More than minor or inconsequential impacts:</u> As above. Additionally, consultation with the relevant local council is required.</p> <p>Demolition or removal from the register requires consultation with Heritage NSW and archival recording.</p>
General / Ongoing Management	<ul style="list-style-type: none"> Changes within the defined curtilage should be preceded by the appropriate level of heritage assessment and approval. Advice and/or confirmation should be sought from the Environment Team prior to undertaking any works. Maintain overall form, shape and scale of the building. The introduction of new buildings or structures within the curtilage is discouraged. If introduced, the ability to view the building 'in the round' is to be retained and not obscured. Maintain existing shallow portico, original window detailing, fenestration, and significant elements. Changes to fabric may be supportable if no feasible alternative is available/to ensure ongoing operation and/or safety. Removal or replacement of non-significant elements (such as lighting, rainwater goods, services, external signage, etc) is supportable, provided that any replacement is appropriate to the building. Reinstatement of sympathetic window glazing and hardware may be suitable.
