HUNTER WATER

SECTION s170 REGISTER

Neath 2 Water Pump Station

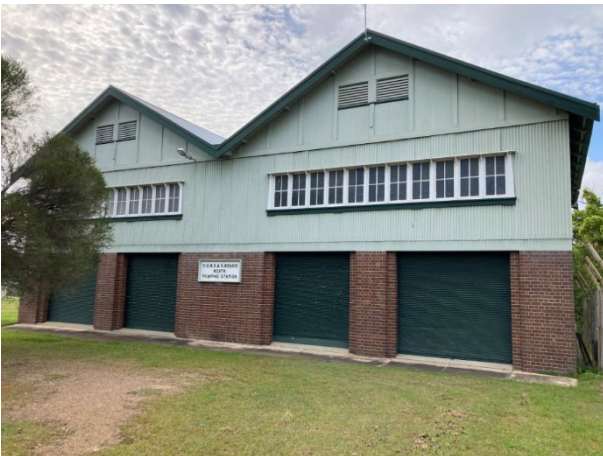
Image 1: Street-facing façade with roller doors

- Removal of non-significant elements (such as recent roller door, lighting, rainwater goods, services, external signage, etc) is supportable, provided that any replacement is appropriate to the building. Reinstatement of sympathetic entrance doors may be suitable.
- Maintain existing shallow porticos, original window detailing, fenestration, and significant elements.

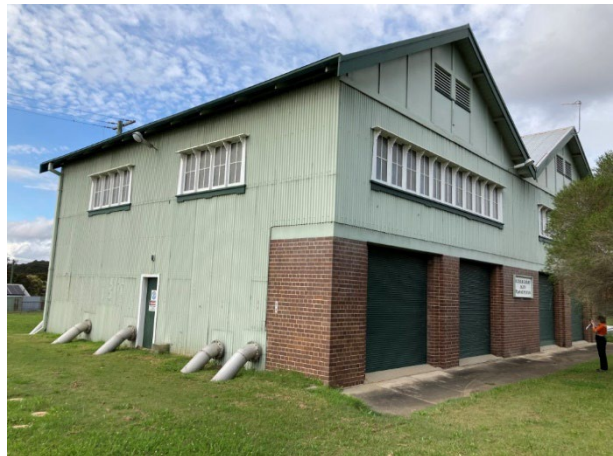
Image 2: Interface between brick detailing and corrugated iron sheets

- Assess and repair damage to external brickwork and corrugated metal sheet cladding, including mortar loss, spalling, cracking, and peeling sheets.
- Assess and repair damage to internal concrete slab floor, including spalling.

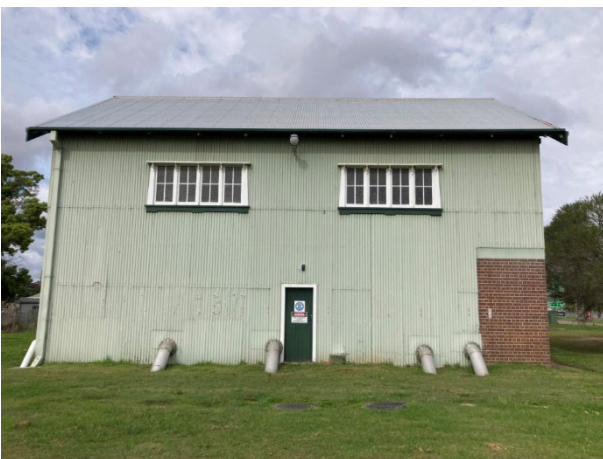
Image 3: Eastern façade

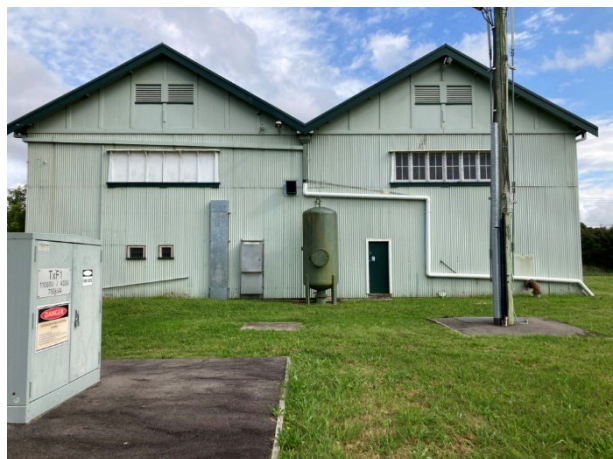
Image 4: Rear façade
