# **Grahamstown Dam**

**Risk Assessment Summary Report**

**Client: Hunter Water Corporation**

27-Jun-2024

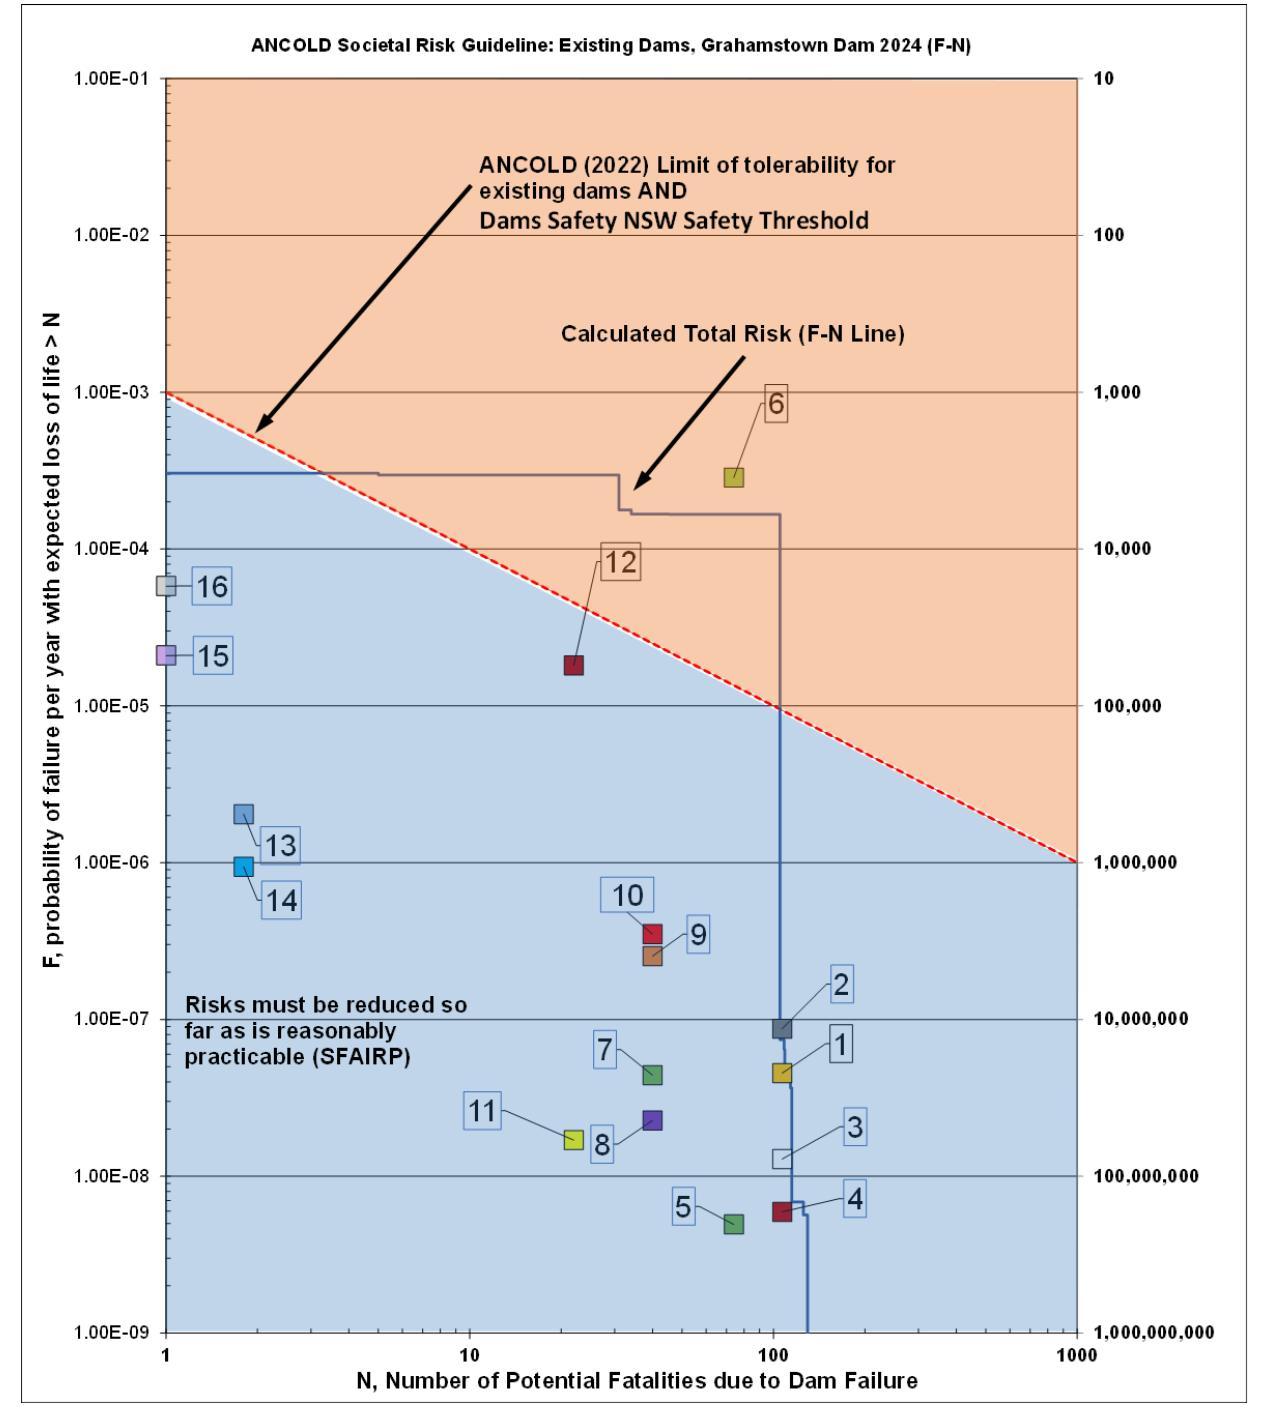
Figure 5 Societal Risk (F-N) Line including F, N pairs representative of the calculated risk (annual probability of failure) and potential fatalities associated with identified failure modes

Figure 5 shows that failure mode 6 (GRA-F6) contributes the most to the calculated societal risk. The total societal risk position for the dam is above the Dams Safety NSW safety threshold for existing dams and the ANCOLD 2022 societal risk guideline thresholds.

The blue line in Figure 5 shows the cumulative risk for all of the failure modes. The red line in Figure 5 shows the safety threshold. Risks above this threshold are considered unacceptable and require risk reduction measures to be implemented to reduce the probability of failure and/or consequences to the downstream community. However, all risks (even those below the threshold) must be reduced so far as is reasonably practicable (SFAIRP).

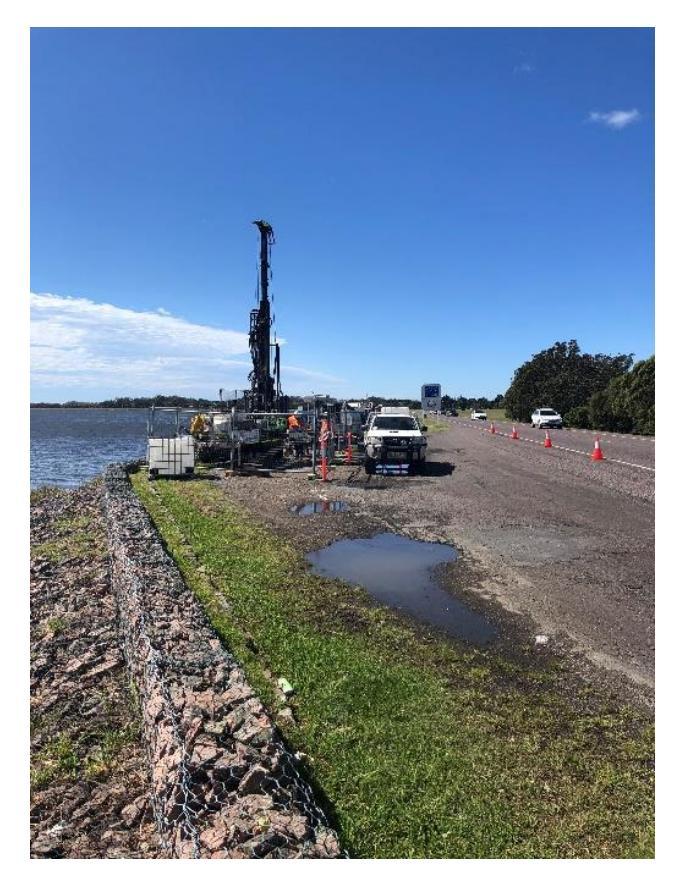
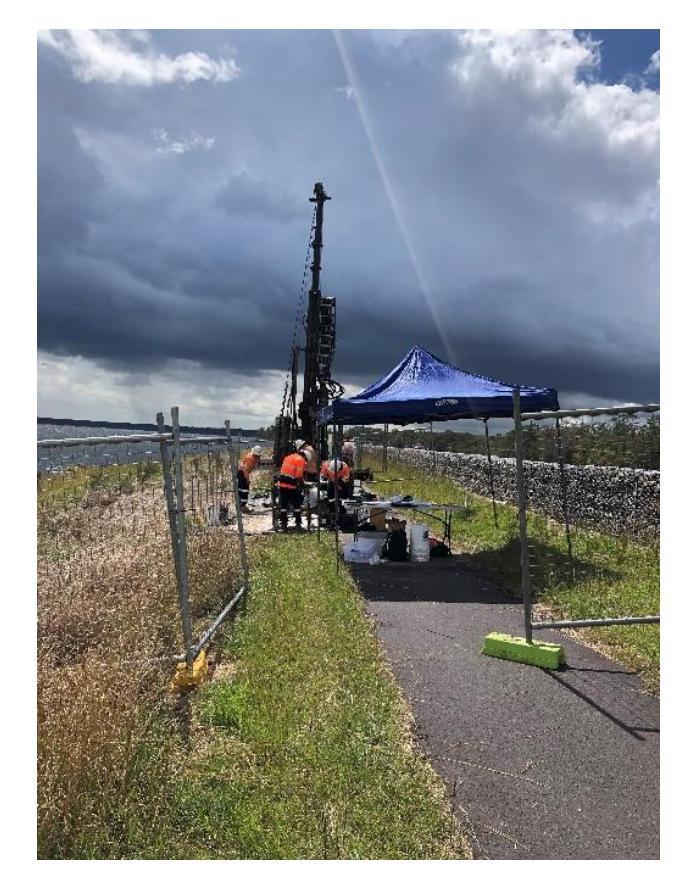
Figure 6 Images showing geotechnical works on Grahamstown Dam

The risks associated with earthquakes have existed since the construction of Grahamstown Dam in the 1960s and is not a result of poor maintenance by Hunter Water or due to inadequate design at the time of the scheme's conception. The risk has recently been understood in greater detail as advances in geotechnical engineering, scientific monitoring, and advanced computer modelling have provided better analytical methods to identify and understand how the sandfill shoulders and sandy foundations of the embankments could potentially behave under earthquake forces. Figure 6 shows images of geotechnical works which were undertaken at the embankments to help inform the risk assessment.
