Hunter Water S170 Register

SHI No.: *Name:*
3630041 Bellbird Water Pump Station

Location 265B Wollombi Rd, Bellbird Heights NSW 2325

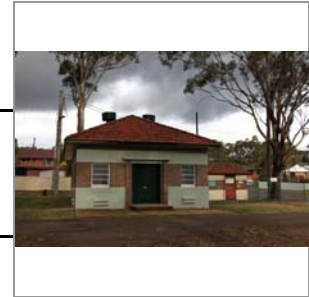
A fairfaced stretcher bond brick structure with painted render to base and head. Marseille tiled hip roof with timber fascia and fibrous cement soffit. Large vent located on roof. Double hung sash windows with weldmesh screen. Remnant gutter over door, which has a recent roller shutter.

Internal description: White painted rendered/plastered walls with concrete floor. Contains three recent pumps and control gear, and two lifting points.

Good condition

- This item contributes to local character and should be conserved.
- Original details should be maintained including doors, windows and original signage.
- New materials should be sympathetic to the nature and character of the original building.
- In the event of major proposed changes, prepare a Conservation Management Strategy and undertake an archival recording.
- Wherever possible, changes should be restricted to the interior of the building.
- Routine maintenance of existing fabric is essential.

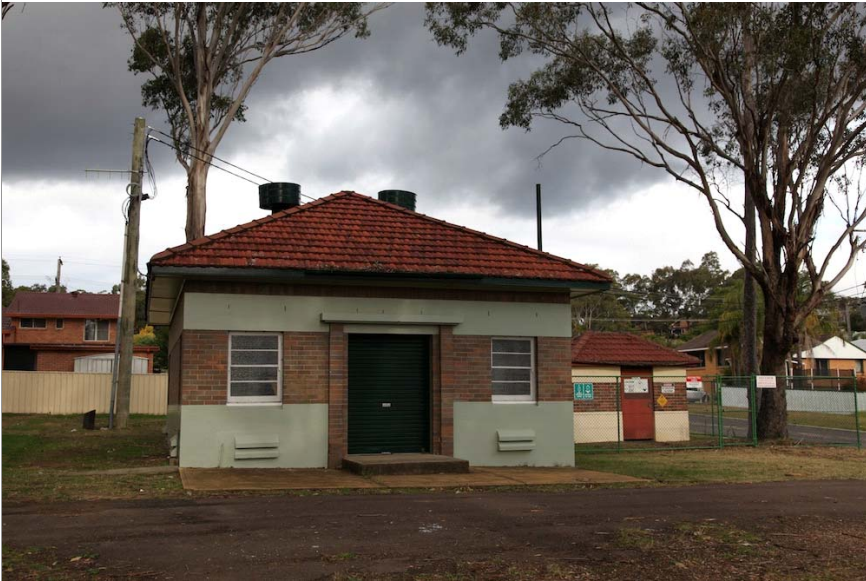
File: Bellbird WPS.jpg

Bellbird Water Pump Station
