Safety, Health and Wellbeing

SAFETY ALERT No. 144 Mild Electric Shock Whilst Working on Metallic Pipes

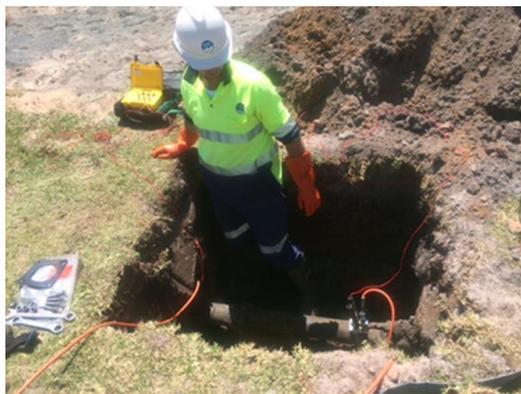
Gloves, Plumb Guard and Bridging Straps in Place

1. Inspect insulating electrical gloves, bridging plates, leads and plumb guard prior to use.
2. Ensure that insulating electrical safety gloves are worn at all times whilst working on metallic water pipes and fittings.
3. Ensure that pipe and fittings are adequately cleaned. Fit the electrical bridging kits to ensure a direct electrical contact between the pipe and the bridging plates. Secure each bridging plate with the ratchet straps.
4. Connect the plumb guard and monitor the unit.
 - **IMPORTANT** If any electrical current is observed at any time during the job, cease work and remove all employees from the job site and section off the area from the public. Contact your supervisor and the relevant electrical authority. Do not carry out any work on the site until clearance has been given by the electrical authority.
