ABORIGINAL CULTURAL HERITAGE ASSESSMENT REPORT

Belmont Drought Response Desalination Plant, Belmont, NSW

PR139685-1 | Belmont Drought Response Desalination Plant Aboriginal Cultural Heritage Assessment Report | 1.8 Final | 23 October 2019

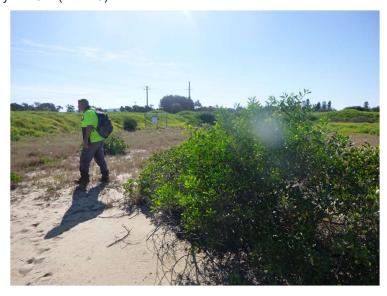
This area comprises two large evaporation ponds associated with the wastewater treatment works. These ponds have been formed by the distribution of large amounts of A horizon sand to form bunds. The base of the dry ponds were able to be inspected where sands were exposed however the bunds were thickly vegetated resulting in a low archaeological visibility of <10% (Plate 1 and Plate 2). Where exposed, the soil within the bunds area was a grey-yellow A2 horizon sand, with a medium, well-sorted grain structure. The sand profile at the base of the evaporation ponds was a dark, yellow-grey loamy B horizon sand with archaeological visibility at 20% (Plate 3).

Plate 1 Evaporation pond with exposed base and vegetated bunds. Image aspect is north-west (RPS 2019).

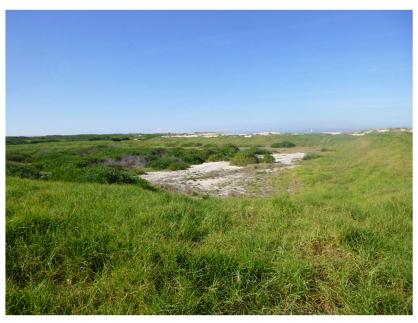
Plate 2 Densely vegetated bunds greatly reduced ground surface exposure. Image aspect is eastward (RPS 2019).

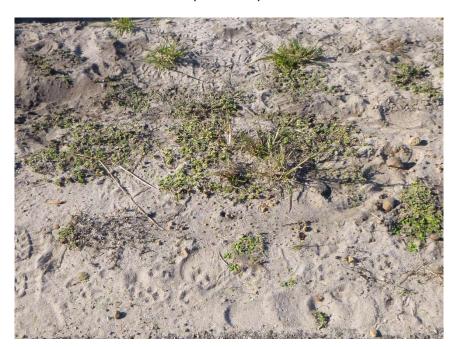
Plate 3 Sample of dark, yellow-grey loamy B horizon sand associated with the bunds (RPS 2019).

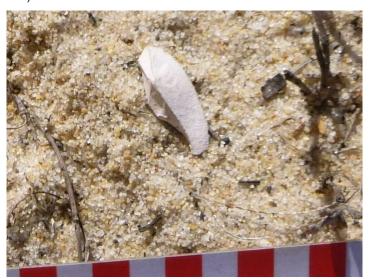
One isolated find, AHIMS #45-7-0397 (RPS BEL IF01), a complete tuff flake, was observed and recorded in the base of one pond (Plate 4 and Plate 5). The flake was located atop a well-sorted, coarse-grained, light grey-yellow sandy B horizon subsoil (Plate 4 and Plate 5). Archaeological visibility in this area was approximately 20% (Plate 6).

Plate 4 One isolated find, AHIMS #45-7-0397 (RPS BEL IF01), a complete tuff flake, was located at the base of a dry evaporation pond. Image shows the dorsal surface (RPS 2019).

AHIMS #45-7-0397 (RPS BEL IF01) has been found to be of low archaeological significance. The site area has been disturbed. The artefact is not assessed to be rare in the context of Belmont/Lake Macquarie archaeology. The type of artefact is consistent with residue of stone tool production and the artefact does not possess any educational potential.

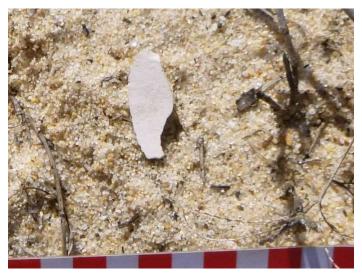
Plate 5 One isolated find, a complete tuff flake, AHIMS #45-7-0397 (RPS BEL IF01), was located at the base of a dry evaporation pond. Image shows the ventral surface and plunge termination (RPS 2019).

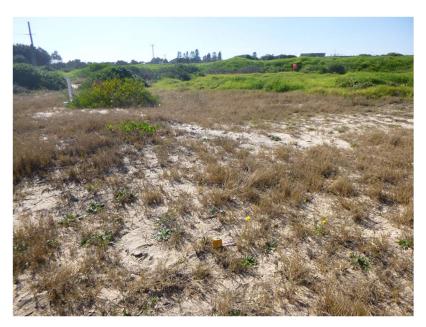
Plate 6 Location of isolated find, a complete tuff flake, AHIMS #45-7-0397 (RPS BEL IF01). Image aspect is north-west (RPS 2019).

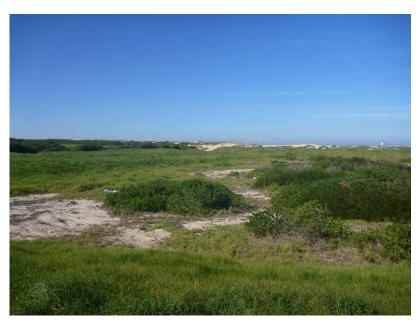
The area allocated for a brine pipeline is located within the existing wastewater treatment works. The area comprises of intermittent exposed soil areas and dense areas of short beach grasses. Archaeological visibility in this area was at 10%. No raw material or cultural objects were identified. The soil profile in this area was a well-sorted, medium-grained, yellow-grey loam sand B horizon subsoil (Plate 7).

Plate 7 Landscape of the proposed brine pipeline. Image aspect is eastward (RPS 2019)

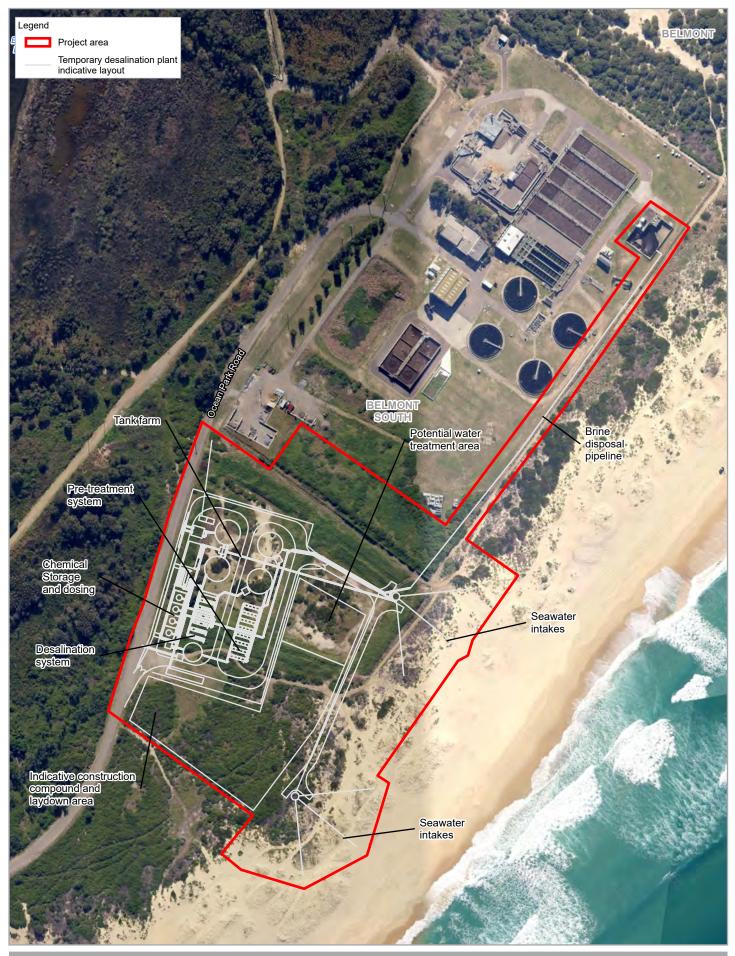
FIGURE 5

The State Significant Infrastructure (SSI) project (SS8896) is for the construction and operation of a drought response desalination plant (Figure 5), designed to produce up to 15 ML/day of potable water, with key components including:
