HUNTER WATER

SECTION s170 REGISTER

Aberdare 1 Wastewater Pumping Station

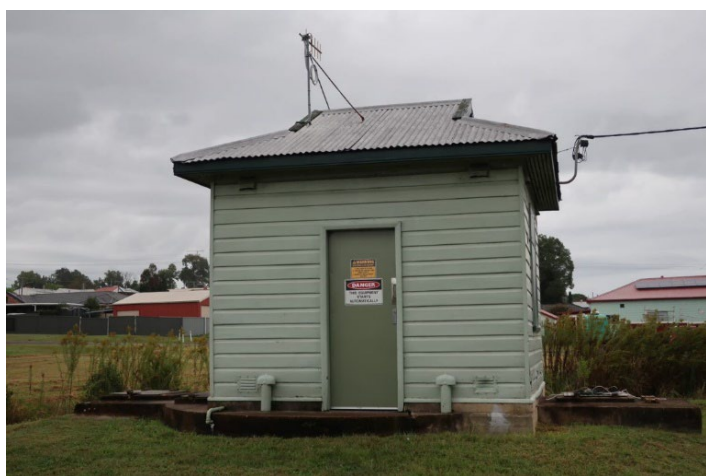
Image 1: East side of Aberdare 1 Waste Water Pumping Station

- Replace the rotten timber boards in the lower three courses to match the original profile. Paint to protect the timber and to match existing.
- Consider adding quad gutters and a downpipe in contemporary coated steel to extend the life of the shiplap boards.
- Assess and investigate the presence of asbestos. If present, replace relevant fabric in a like-for-like manner with a more suitable material.

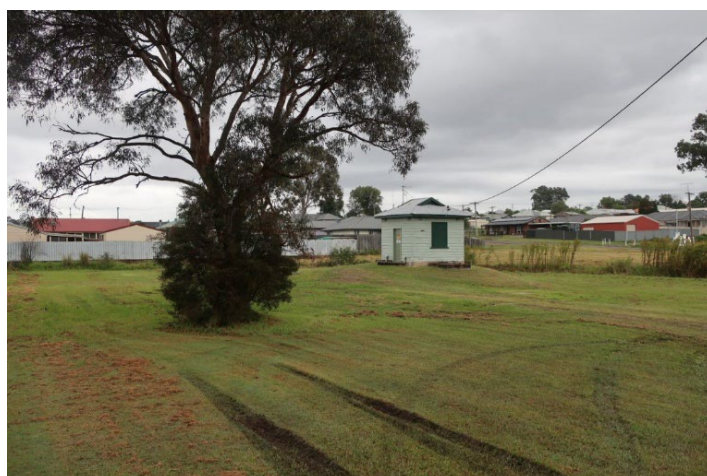
Image 2: Waste Water Pumping Station, looking south-west

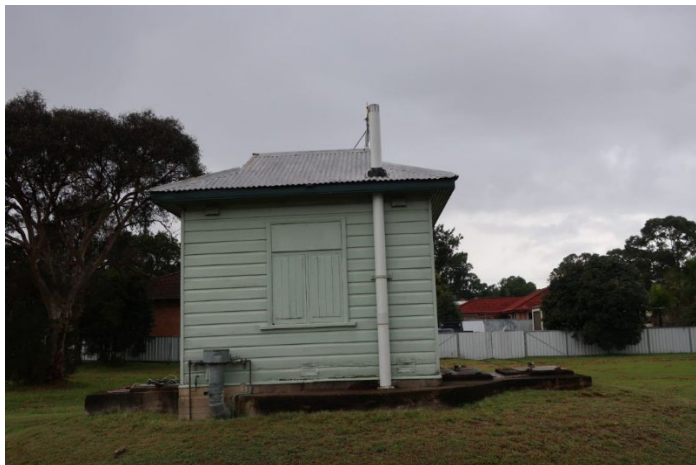
Image 3: West side of Aberdare 1 Waste Water Pumping Station

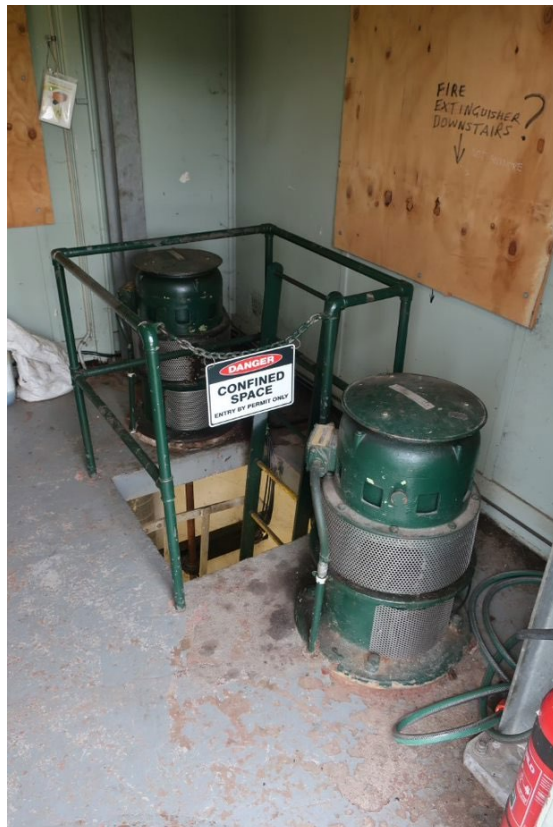
Internal Appearance	The interior is lined with fibre cement with timber battens. The guard rail around the access pit, and its ladder, appear to be original.
Overall Condition	Moderate
Moveable Heritage Objects	None identified.

Image 4: Aberdare 1 Waste Water Pumping Station, original ball and pipe handrail around the access to the pit
