HUNTER WATER

SECTION s170 REGISTER

Burwood Beach Wastewater Treatment Works

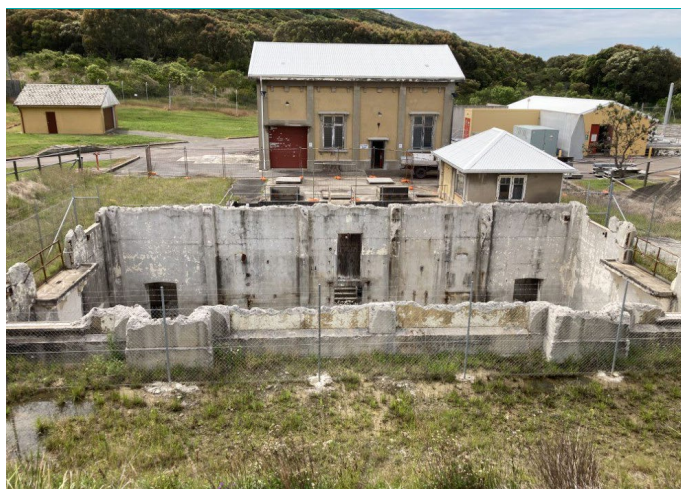
View of the partially demolished Screen House (foreground) and intact Pump House (background)

The pumping station building, or Pump House is connected by a tunnel to the screening chamber building or Screen House. At present, only the footings/basement walls of the Screen House remain on site, as the remainder of the building was demolished c. 2020. Prior to the removal of the majority of the building, the building was similar in style to the pumping station building/Pump House but was in much poorer repair with a collapsed roof.

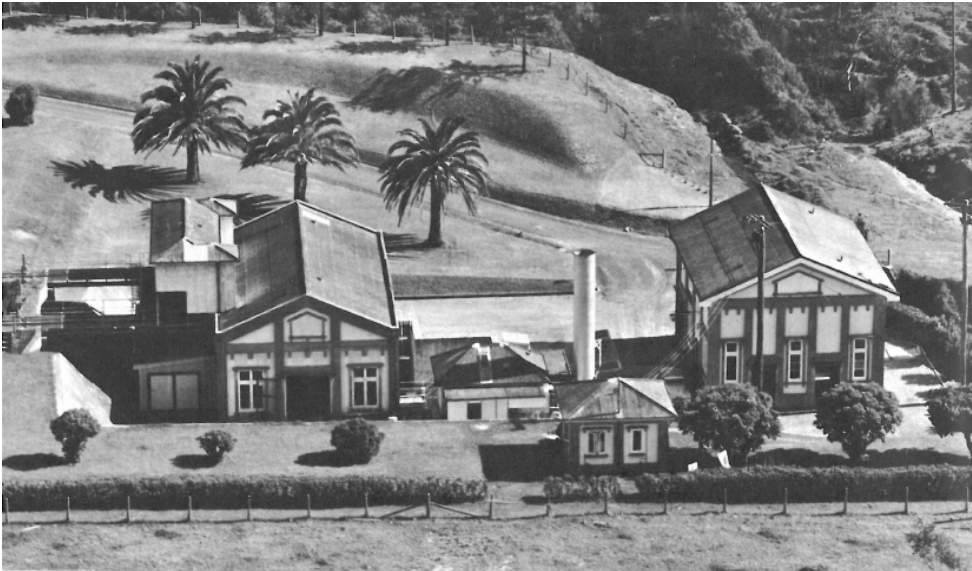
Figure 2: View of the 1936 buildings soon after their completion (date unknown)
Source: Photograph courtesy of Hunter Water

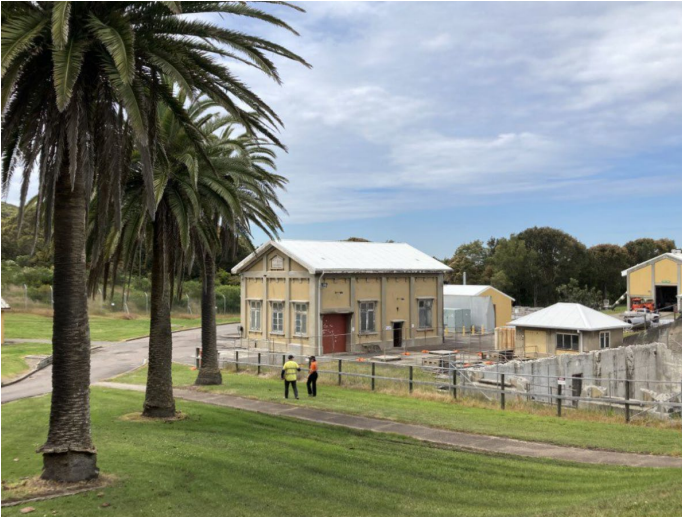
Image 1: View of palm trees, entrance driveway, Pump House (left), Change House (middle) and partially demolished Screen House (right)

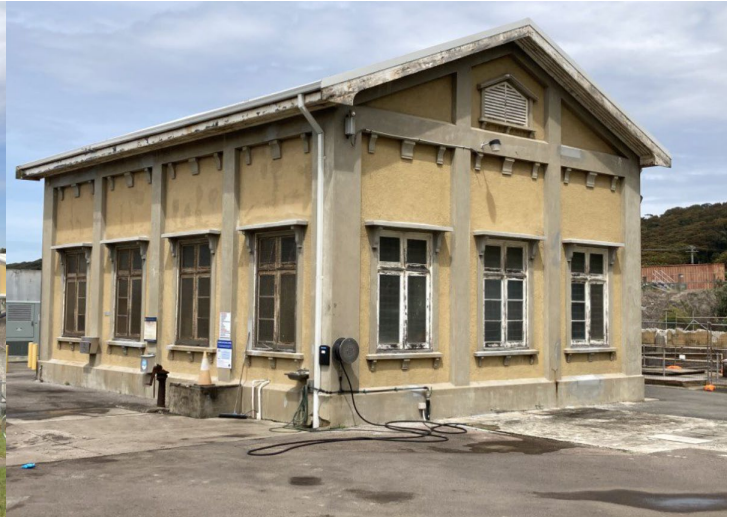
Image 2: View of the northern and eastern elevations of the Pump House

The pumping station building, or Pump House is a two-storey rendered masonry building with rendered concrete awnings over doors and windows, decorative rendered sills, timber windows and framed and sheeted doors. The roof is timber framed with modern corrugated sheeting and slatted timber eaves; it is in good condition with the roof sheeting having been recently installed. The louvered vent at the top of the face has been waterproofed/sealed.

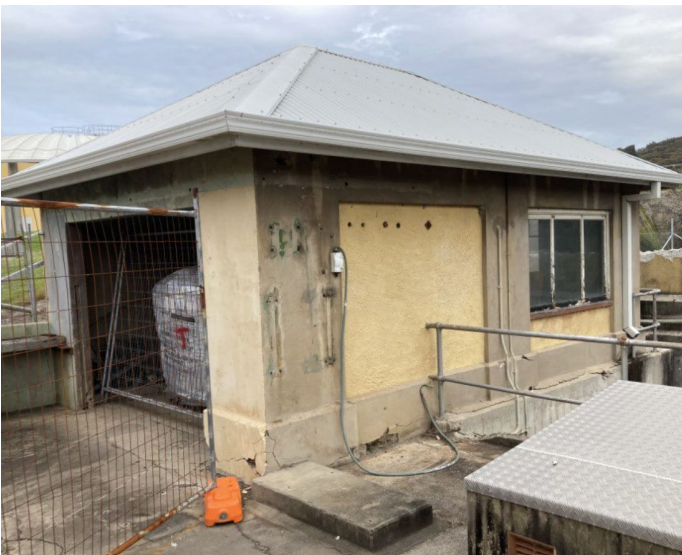
Image 3: View of the Change House facing southwest

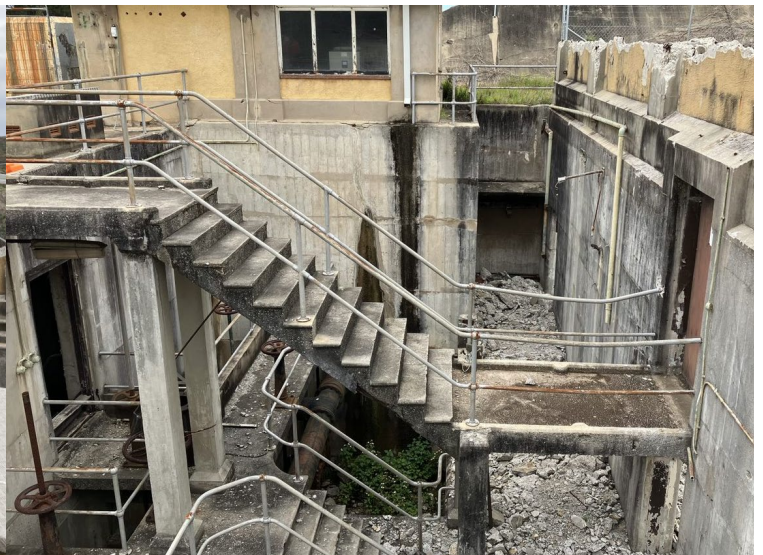
Image 4: View of the remains of the Screen House showing *in situ* equipment

<p>original timber joinery is located in one corner. Evidence of original fixings (e.g., lights, gantries and pulleys) remain present.</p> <p>The Screen House is now empty of all equipment and internal structures as a result of its partial demolition. The original layout of the building and sub-surface equipment remains somewhat legible despite this.</p> <p>The Change House is largely devoid of internal features or elements. Limited examples of original features (e.g., power or light switches) remain present.</p>
Overall Condition	Fair to good.
Moveable Heritage Objects	<ul style="list-style-type: none"> Any original equipment remaining on site that is no longer <i>in situ</i>.

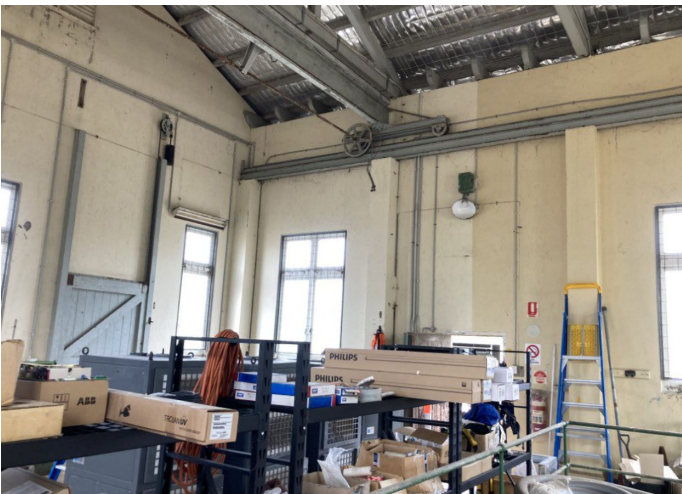
Image 5: Internal view of the Pump House showing gantries, pulley, timber door, original windows and original light fittings

The Pump House contains a sewage pumping station with a covered dry well and limited original pumping gear and equipment (now predominately used for storage). A foreman's office featuring

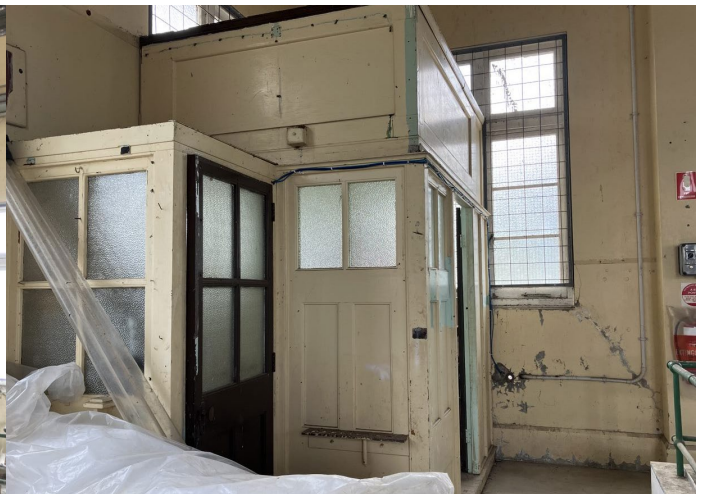
Image 6: Foreman's office within the Pump House showing original joinery

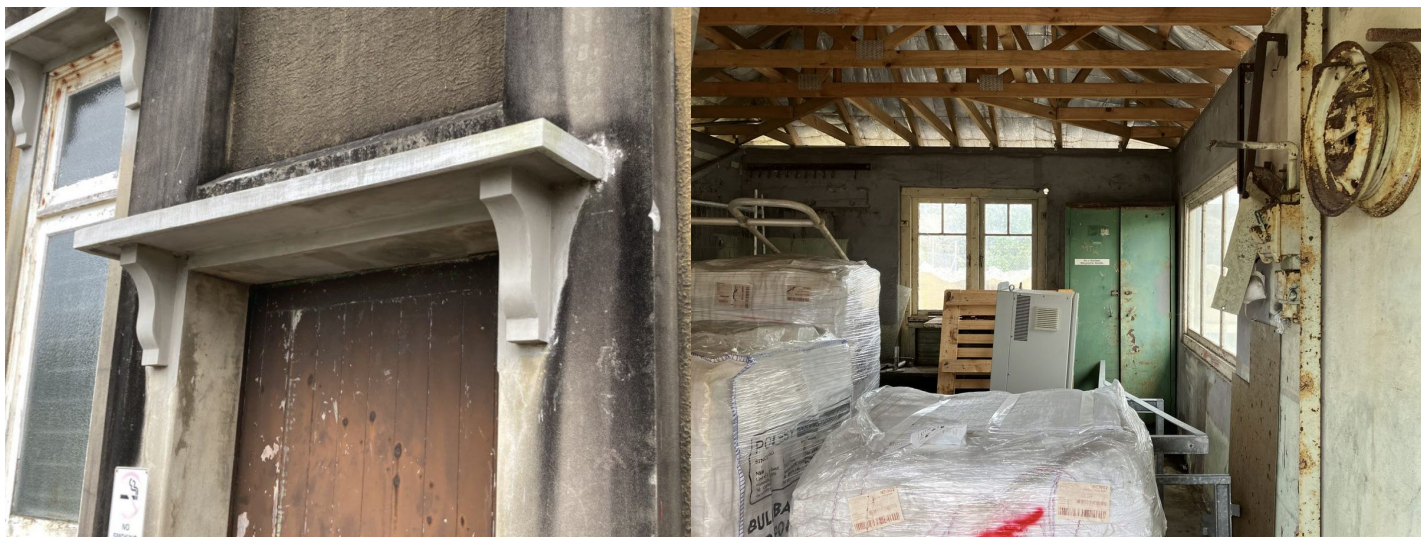
Image 7: Detail of joinery and other decorative elements to the exterior of the Pump House (noting the decorative projecting hood has been sympathetically replaced)

Image 8: Internal view within the Change House
