HUNTER WATER

SECTION s170 REGISTER

Chichester Dam Complex

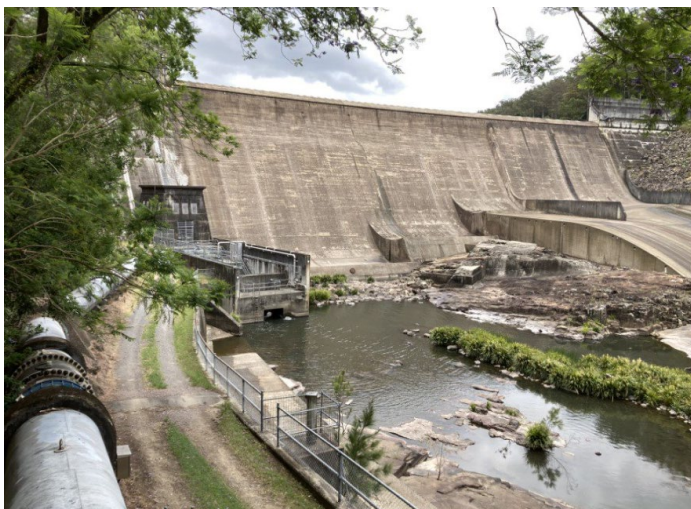
View of the Chichester Dam

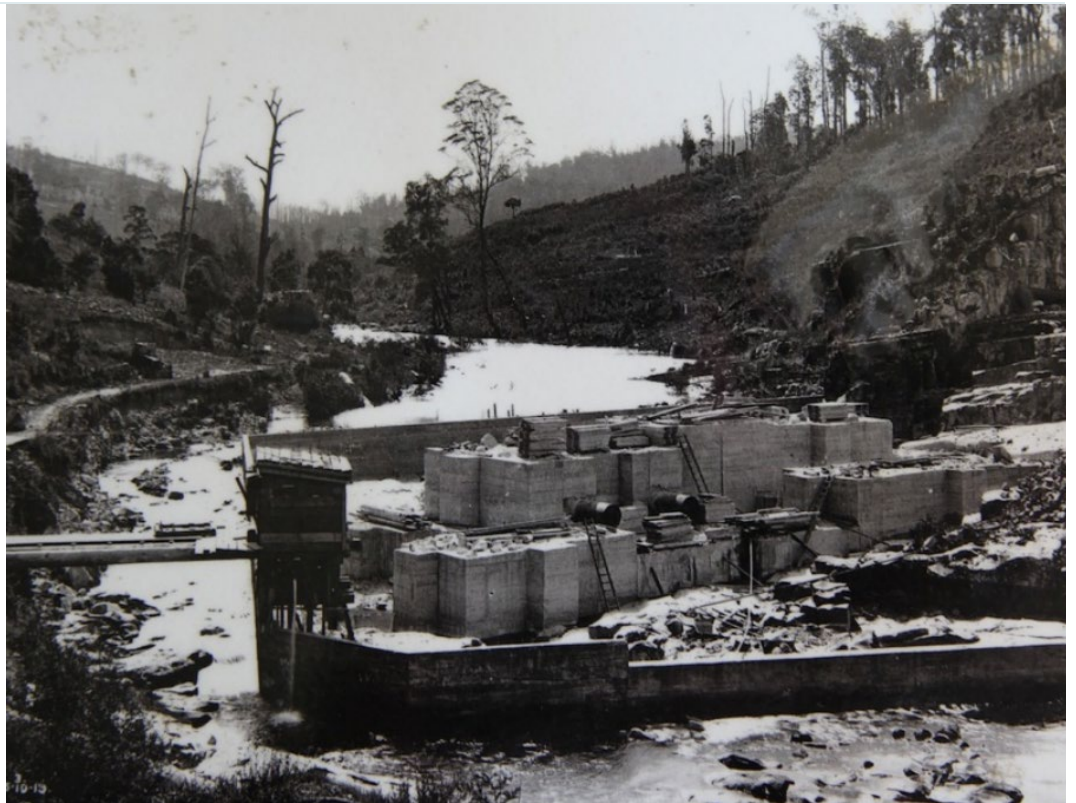
Figure 4: The Dam Wall under construction, c.1919

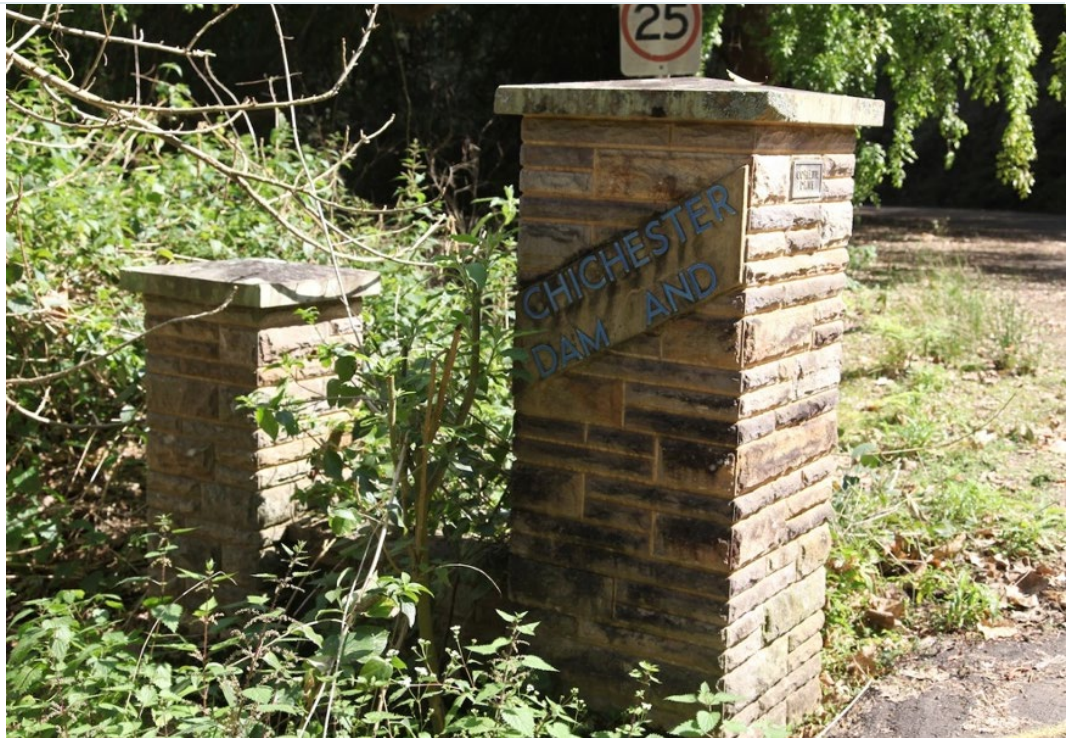
A pair of sandstone entrance pillars marks the entrance to the Chichester Dam site. There is signage on the pillars, however, one sign is missing on the right-hand pillar, which also exhibits vehicle Damage. The sandstone pillars appear to be original to the site.

Photo 1: View of the western entrance pillar

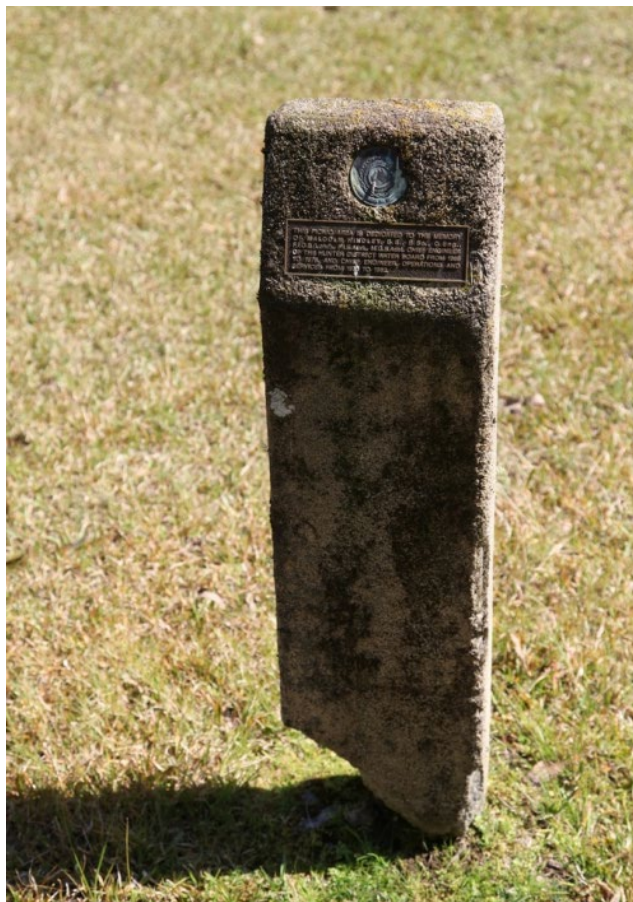
The Memorial Pillar is located within the Mal Hindley Memorial Park, which is a flat, grassed area below the No 1 Quarters. The Memorial Pillar is concrete and was installed in recognition of Hindley, who was Chief Engineer with the Board from 1966-1976 and Chief of Engineering Operations and Services from 1976-1982. It features a bronze plaque with an Institution of Engineers bronze logo above. The Memorial has a Damaged base.

Photo 4: Memorial to Mal Hindley located within the Mal Hindley Memorial Park

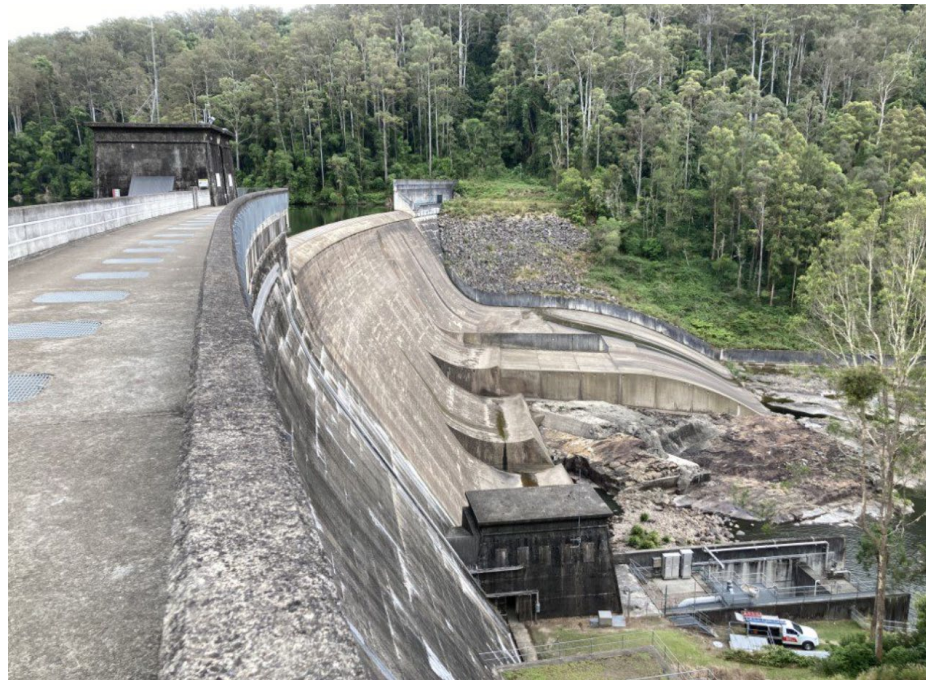
The Dam Wall is a cyclopean concrete wall with later spillway alterations. It has been altered and changed in several instances, including being both lowered and raised, with evidence of this in the changing colour and concrete style of the wall. The Dam Wall shows evidence of old surface cracks, discolouration and alteration, including the installation of several metal clad conduits down the Dam face.

Photo 5: Elevated view of the Dam Wall

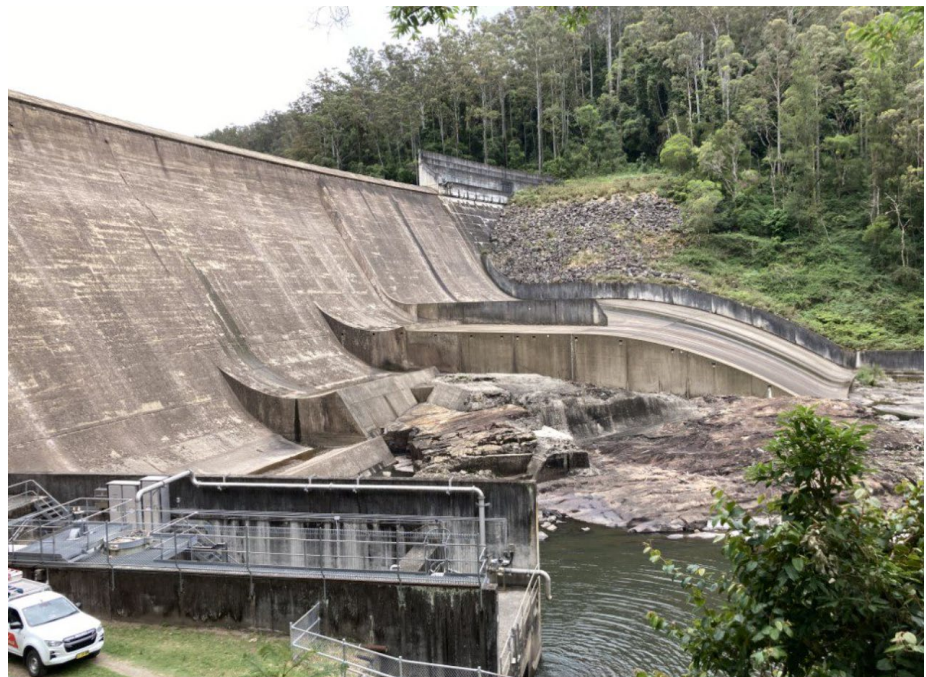
Photo 6: Lower view of the Dam Wall

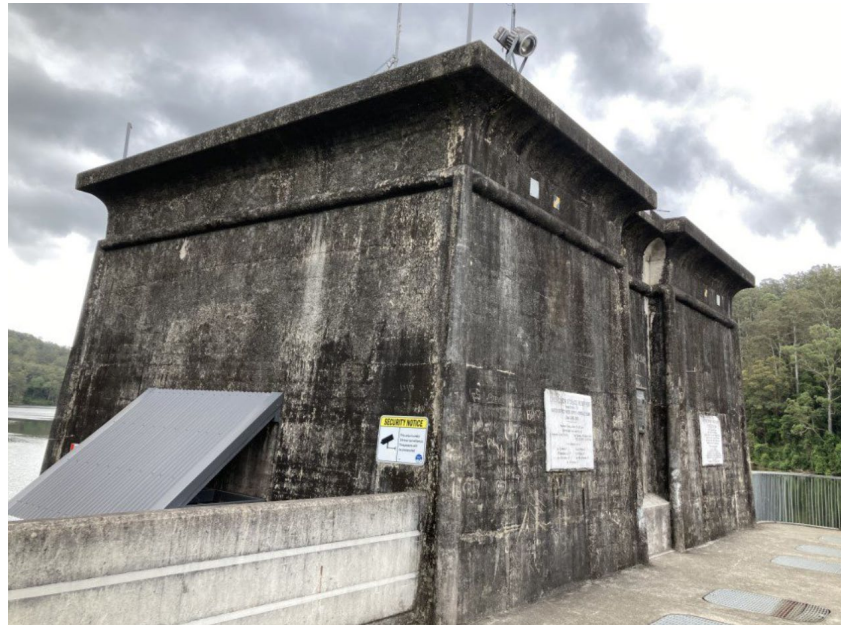
A mass concrete Egyptian Revival style structure, the Upper Valve House has balconies to the northern and western sides, with later timber and colourbond awnings. There are two marble and one bronze plaques on the eastern face of the structure and entry is obtained on the southern side. There have been alterations to the roof drainage and an access hatch has been cut into the roof to allow the installation of new valves. The entrance to the Upper Valve House was originally via a central doorway from the Dam Wall, however, with the raising of the wall, a new staircase was constructed to an altered opening in the south side of the building.

Photo 7: External view of the Upper Valve House

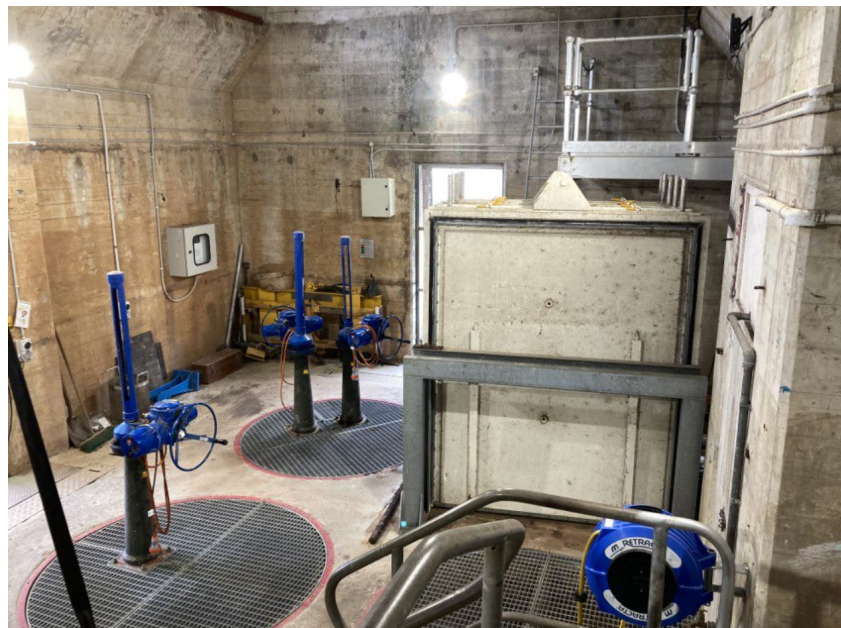
Inside, there are three pits with cast iron floor plates and five valve stems, a modern overhead crane to lift stopboards into one of five slots and a modern steel gantry and ladder. There is modern steel mesh over the doors and a mesh cage around the eastern balcony. Many of the lights and conduits are surface-mounted and the front door and windows were infilled when the Dam Wall was raised.

Photo 8: Internal view within the Upper Valve House

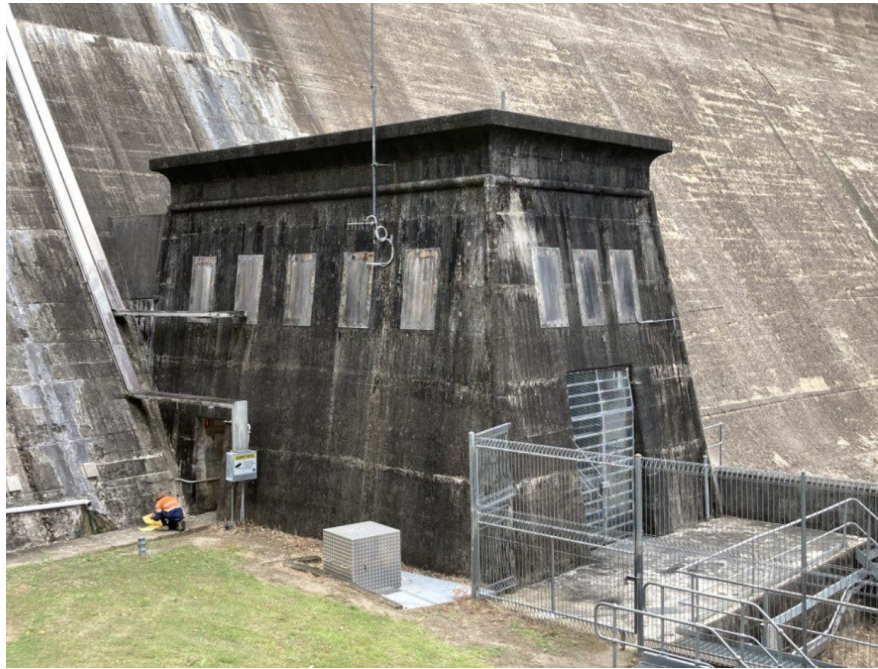
The Lower Valve House (originally designated the Outlet Valve House) is a mass concrete structure, built in the form of a truncated pyramid with a flat roof. The concrete is off-form, with vertical form marks and pouring joints. The walls are about 1,500 millimetres thick at the base. There are five window openings on the southern side, and three on the eastern side. All the windows are covered with later unsympathetic plastic panels. There is a personnel doorway in the southern wall and a double doorway in the eastern wall. Both of these have modern steel mesh doors. Just to the south of the building is a valve pit.

Photo 9: External view of the Lower Valve House

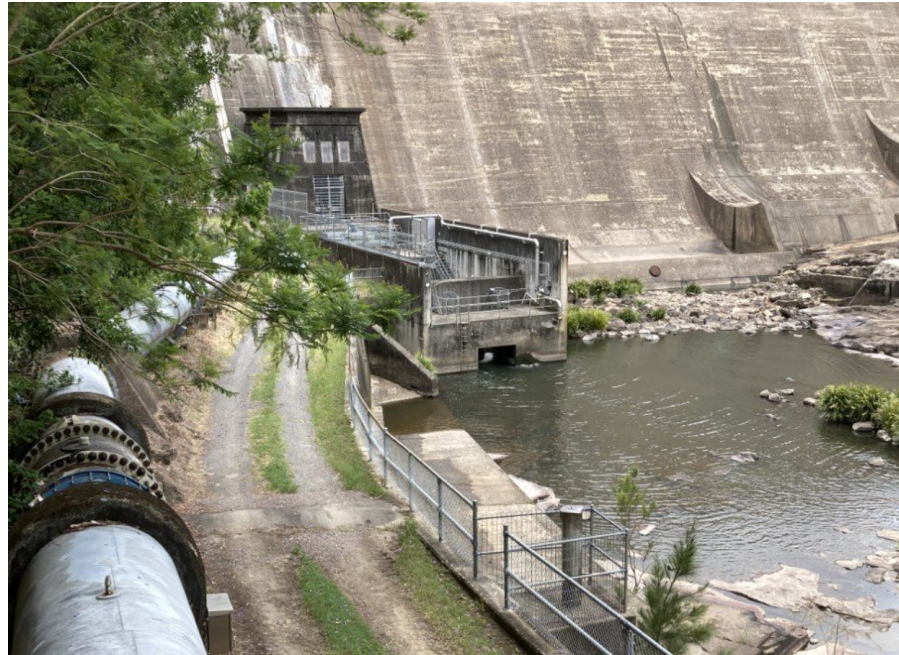
The pipeline in the Dam precinct consists of a welded steel 42-inch (1.08 metre) pipe, painted silver, supported on cast-in-situ concrete footings with precast concrete saddles. At intervals, the pipe is surrounded by a double arched concrete support structure. This pipeline replaces an earlier pipeline that was constructed in timber.

Photo 11: View of the pipeline in relation to the Lower Valve House and Dam Wall

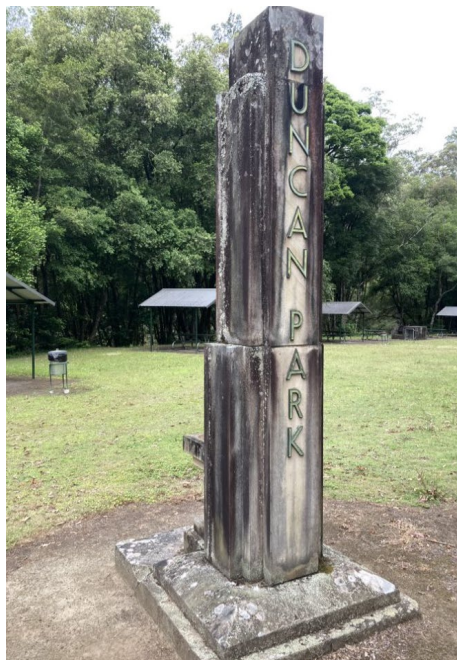
The Duncan Park Memorial is a vertical Art Deco style sandstone memorial, about 2.5 metres high, with green enamelled bronze letters to the back. The memorial includes a working water fountain on the reverse side, with a bronze plaque above the bubbler. The dedication is made to FK Duncan, a former Board president, and Sir Roden Cutler unveiled it on 26th October 1968.

The pointing is in poor condition and the blocks are beginning to separate. There is some lichen staining and water ingress at the top. The plinth is cracked and displaced in several locations. The lettering is dulled but otherwise is in good condition.

Photo 16: The Memorial (front and side views)

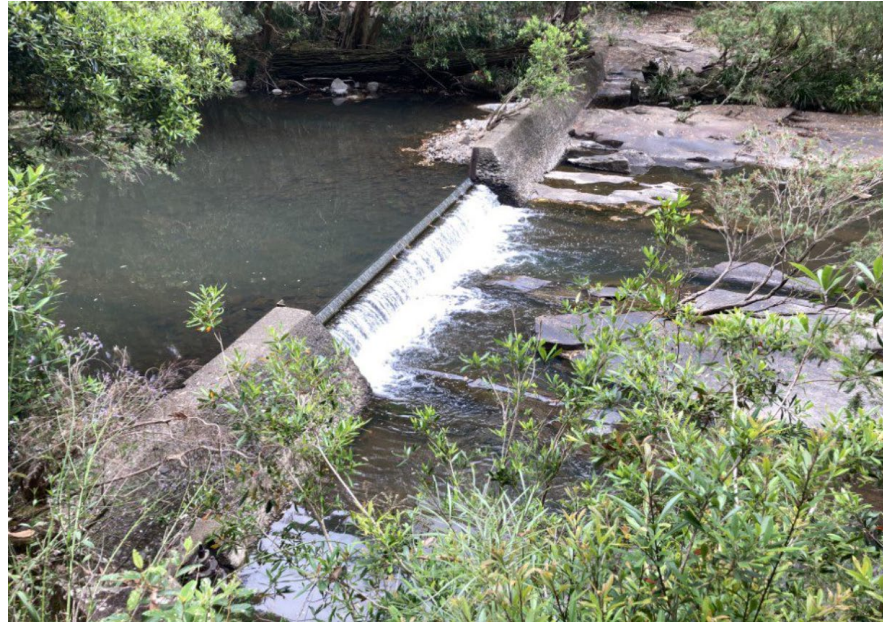
Photo 17: The Weir as viewed from the adjacent walkway

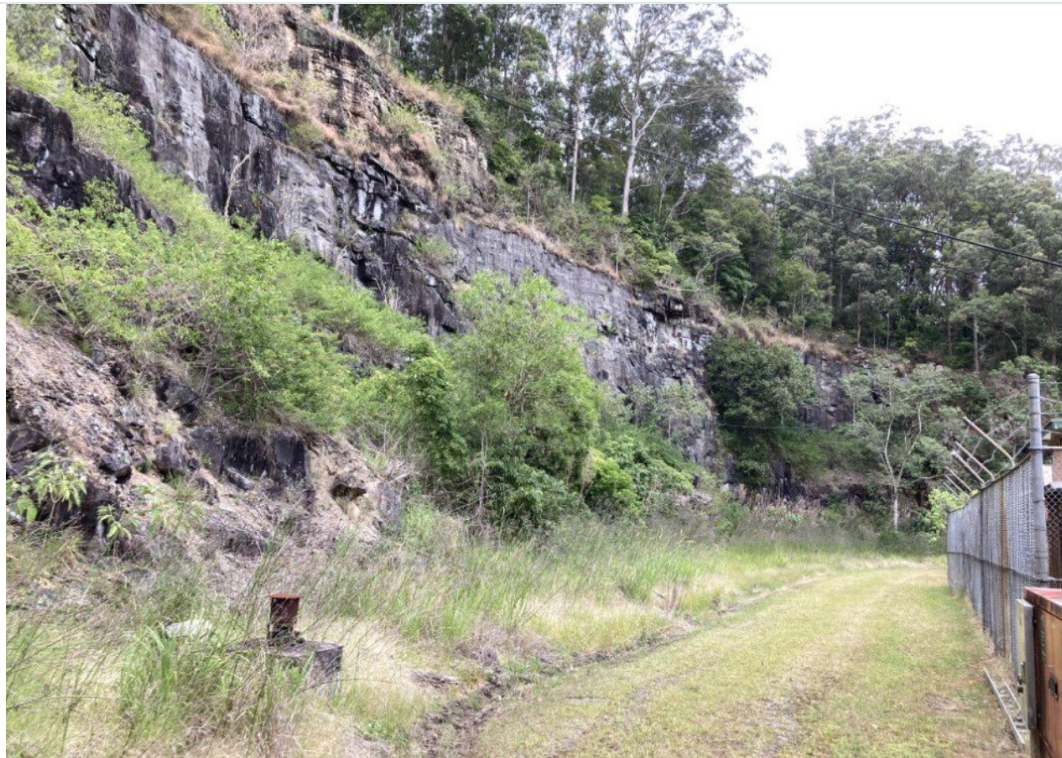
The former quarry face rises about 15 metres above the depot and is surmounted with regrowth vegetation. A series of timber power poles runs along the top of the quarry wall, with a line running down to a pole transformer at the depot. The quarry was originally excavated to supply stone for the concrete of the Dam Wall. The stone was transported from the quarry via an overhead cableway. No evidence of the cableway survives.

Photo 19: View of the quarry face with one of the post-tensioning samples visible at ground level

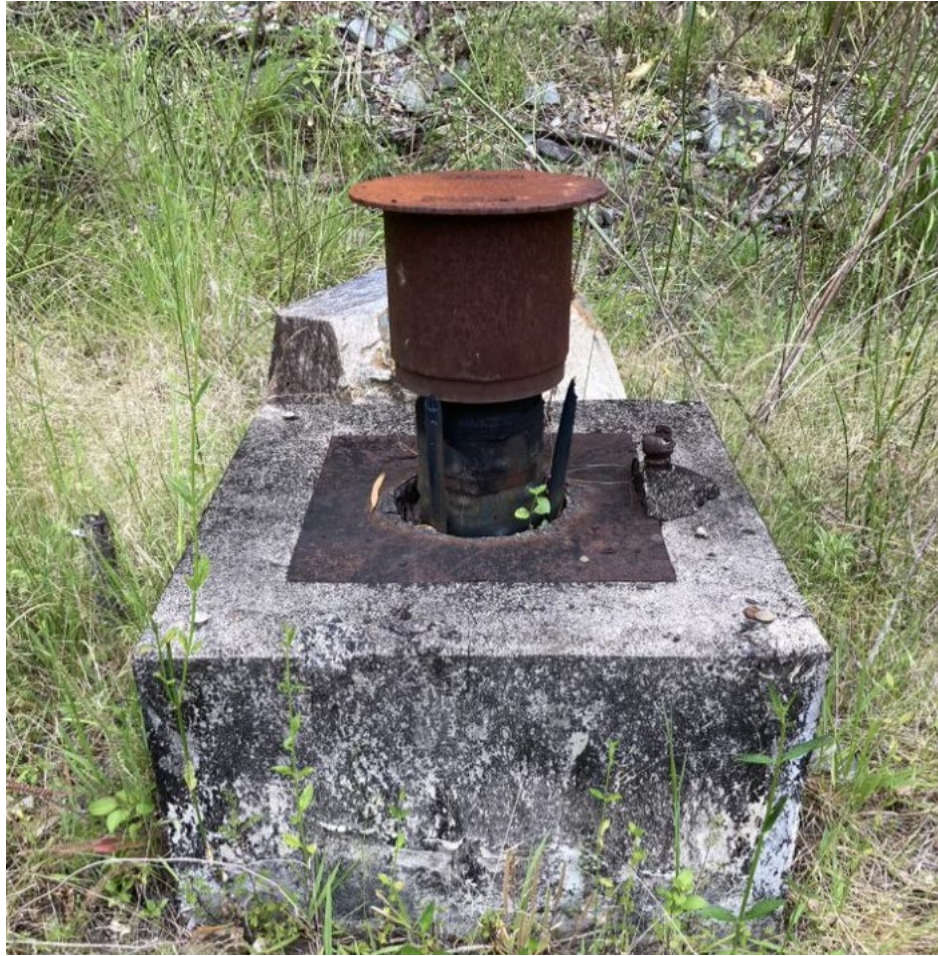
There are three samples of the post tensioning system installed in the Dam Wall. These are all located near the base of the quarry face and give an opportunity to examine the details of the post tensioning system installed in the Dam Wall.

Photo 20: One of the Post-tensioning samples within the Depot Precinct

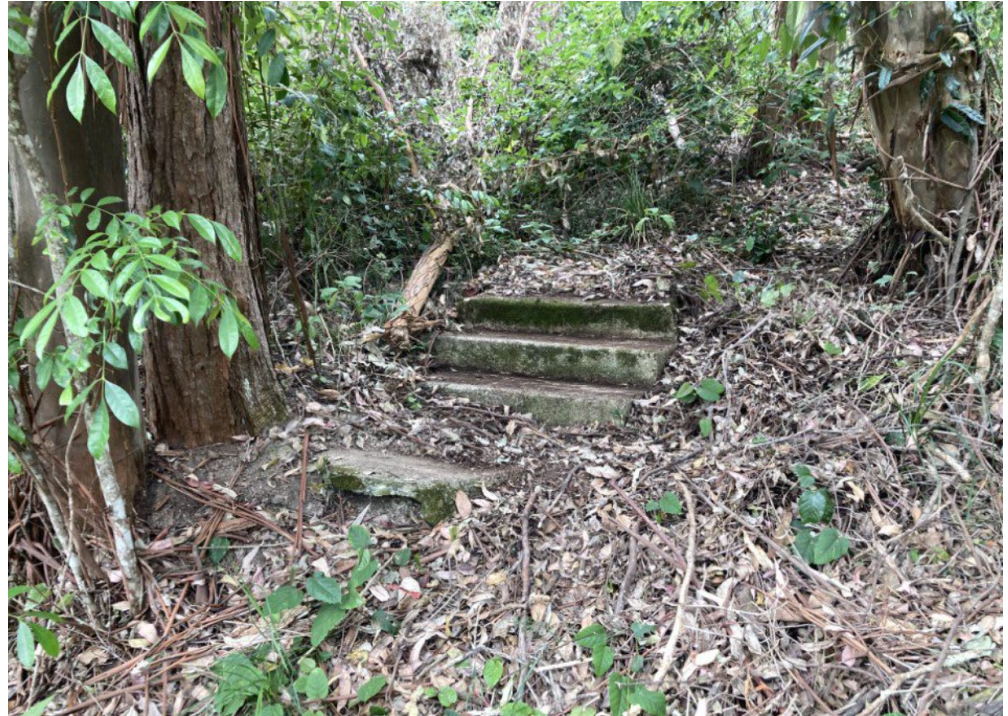
The significant growth of lantana has restricted access to the former village site in its entirety. However, *in situ* archaeological remains of the village are present within cleared areas. This includes footings, stairs, and remnant building materials. Other features that may be present and discernible include street and drain layouts, toilet pits, rubbish dumps, occupational deposits, etc. The living conditions of village residents are an important element of the site's history, which should be interpreted.

Photo 21: Remnant stairs within the former Construction Village

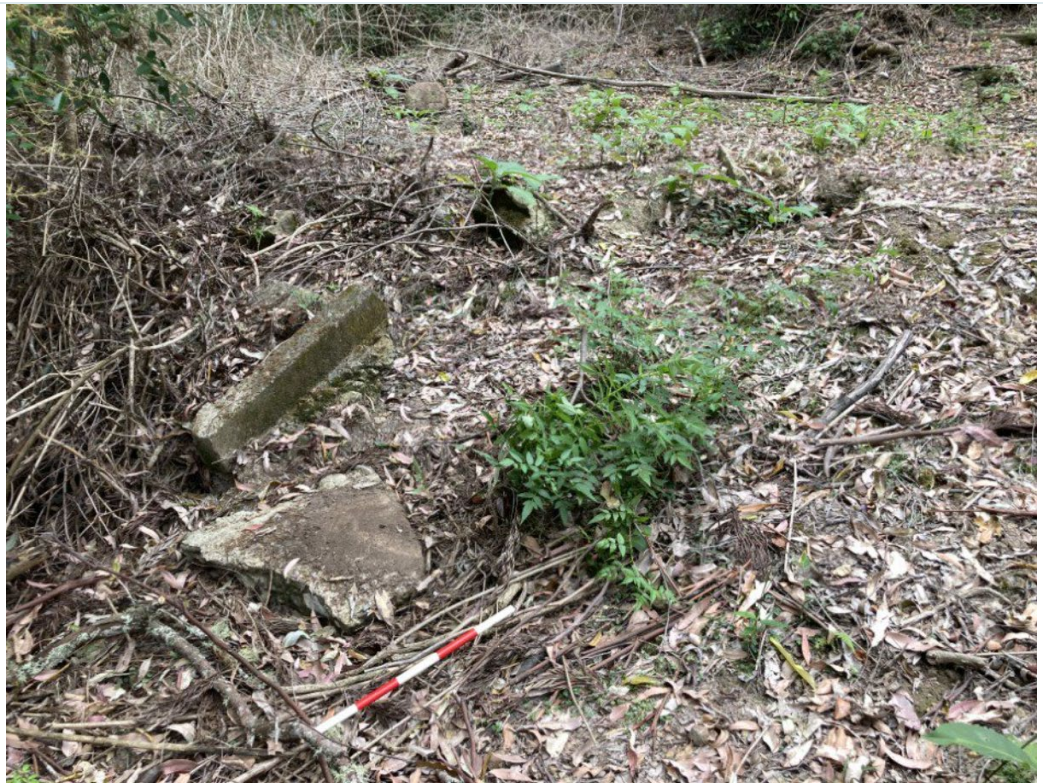
Photo 23: Example of typical remnants present at the Former Construction Village
