HUNTER WATER

SECTION s170 REGISTER

Hunter River Tunnel

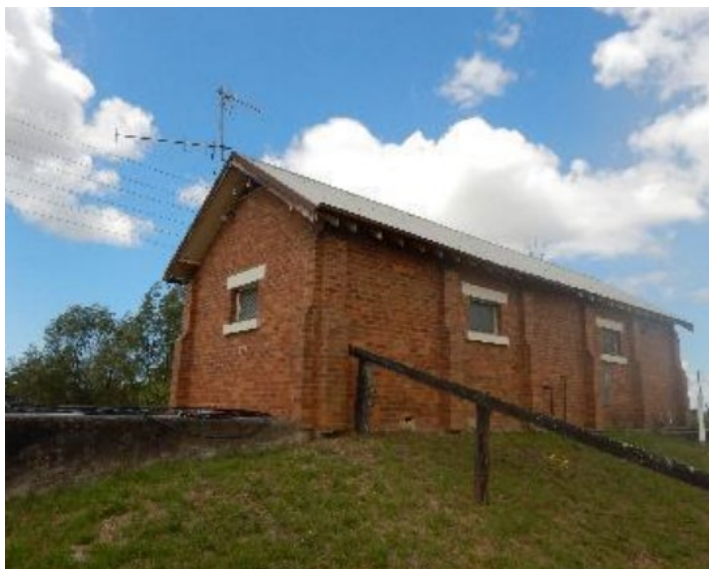
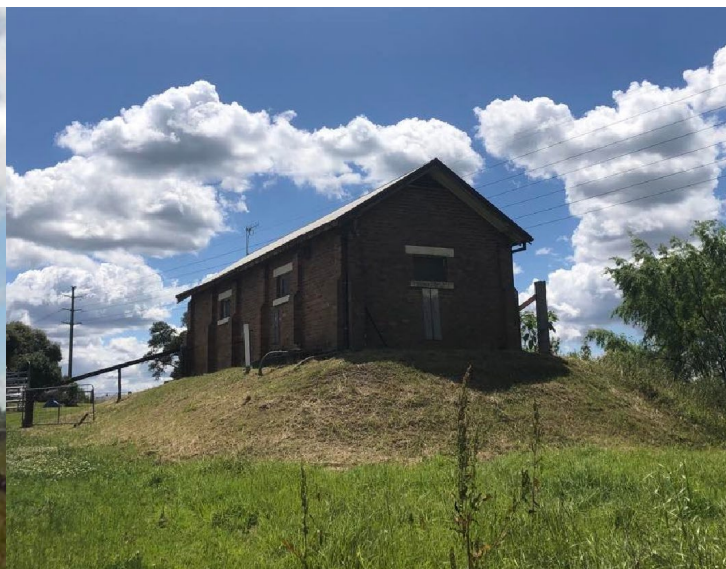
Image 1: Northern valve house facing southeast

Image 2: Northern valve house facing northwest

Setting	The Tunnel crosses the Hunter River in a rural area. The valve houses are located within rural properties on either side of the Tunnel.
External Appearance	<p>The Hunter River Tunnel is concrete lined and contains two DN900 pipelines with sufficient room for personnel access. The tunnel is approximately 200 metres long and is accessed each side of the Hunter River through vertical shafts. Access ladders and platforms within the shafts were replaced in the 1970s. The cast iron pipes of the Tunnel have been progressively upgraded, however the 90-degree bends at the base of shafts have not been replaced.</p> <p>Enclosed brick valve houses have been constructed on either side of the Hunter River, over each of the shafts. The southern valve house was constructed in 1961-62 to replace a previous valve house; it is of a simple and utilitarian design and construction and is not significant. The northern valve house is original to the Tunnel and dates from the mid-1920s. It is a face-brick, single-storey building that is rectangular plan and features a timber-framed gabled, king post roof clad in corrugated steel. There are timber vents to the gable ends and the walls have external engaged piers that are raked as buttresses. The piers rest on concrete footings and the floor of the building is a concrete slab. The building has windows on all sides and a central double door on the south-eastern side. Window and door joinery is timber and sills and lintels are reinforced concrete. While simple in design, the building is more decorative and more aesthetically distinctive than the southern valve house.</p>

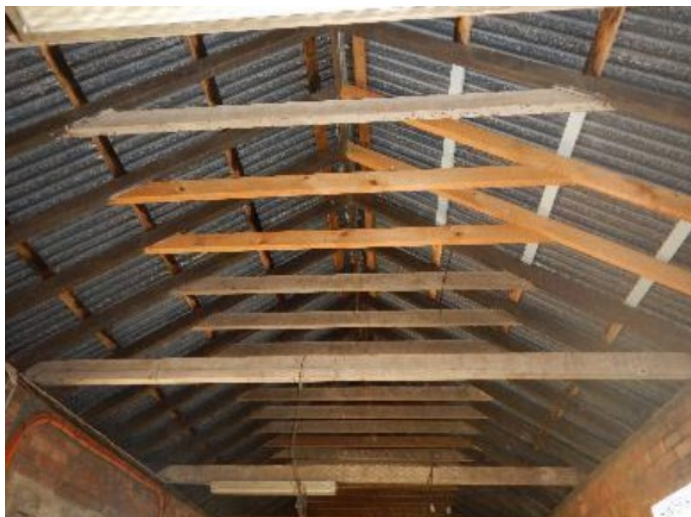
Image 3: Timber roof structure within the northern valve house

Priority Conservation Works	<ul style="list-style-type: none"> • Check over timber to northern valve house and repair/replace as required. • Inspect and assess concrete slab of the northern valve house and stabilise as required.

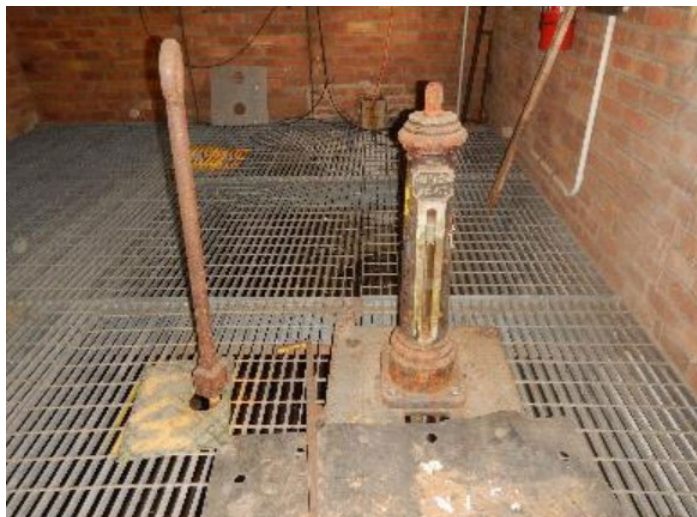
Image 4: Part of the valve system within the northern valve house

The Tunnel forms part of the wider Chichester Trunk Gravitation Main (CTGM), which conveys water from Chichester Dam to the water distribution system that serves Newcastle, Lake Macquarie and the lower Hunter.
Internal Appearance	<p><u>Southern Valve House:</u> Internally, the walls are face brick and the roof panels and joists are exposed to view. Below the level of the floor are the valve chamber and the shaft. The chamber walls are parallel to the walls of the building and the shaft is diagonally oriented to the alignment of the tunnel. A timber-board floor is in place over the valve chamber whereas the shaft is not covered but access is restricted by steel railing and fencing.</p> <p><u>Northern Valve House:</u> Internally, the walls are face brick and the roof framing is open. Below the level of the floor are the valve chamber and the shaft. The chamber walls are parallel to the walls of the building and the shaft is diagonally oriented to the alignment of the tunnel. Steel grate floors are in place over the shaft and valve chamber. Some original equipment associated with the valve system remains <i>in situ</i>.</p>

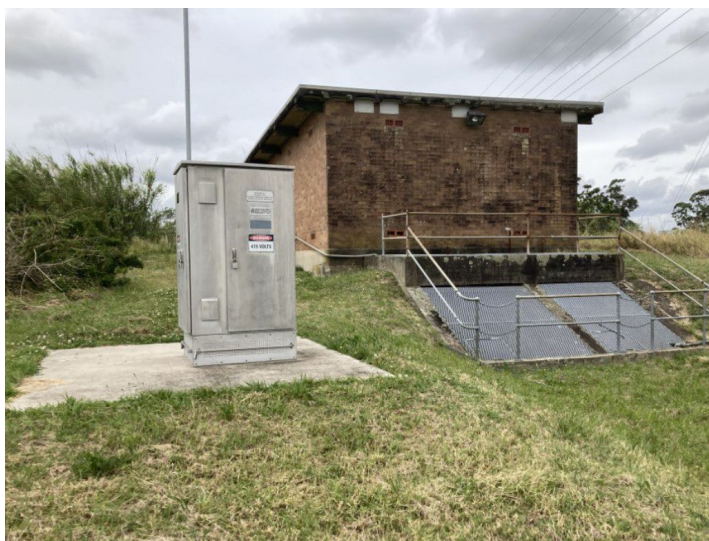
Image 5: Southern valve house

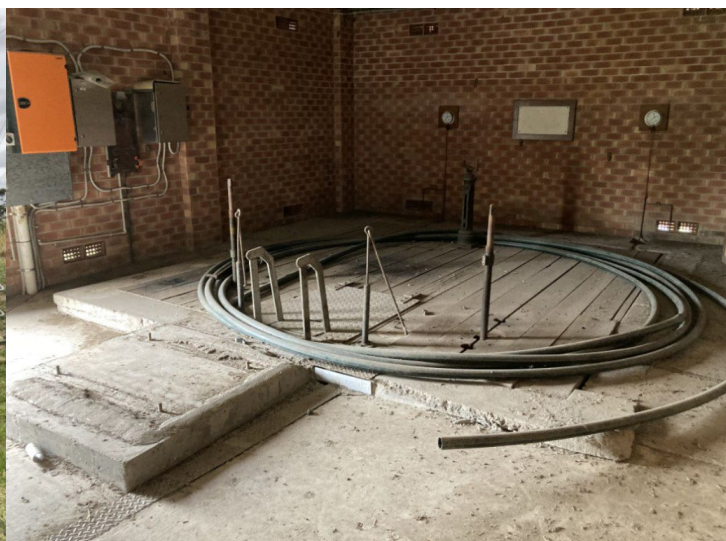
Image 6: Internal view within the southern valve house
