# HUNTER WATER

## SECTION s170 REGISTER

## Lambton 1 Water Pump Station

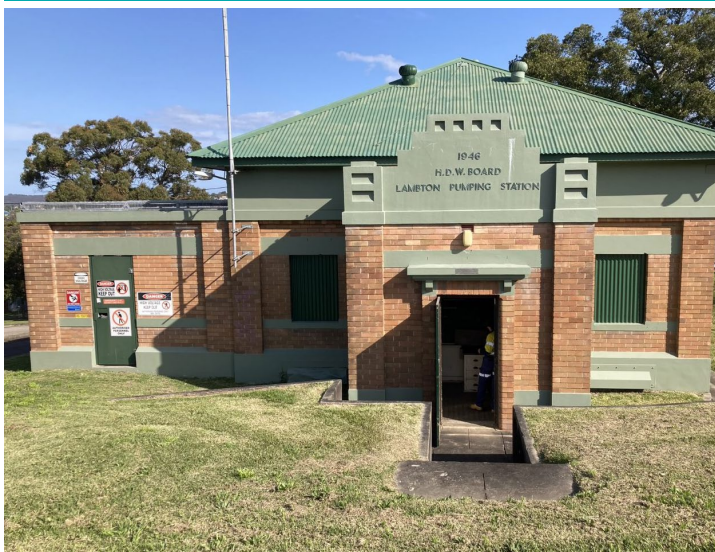
Principal façade of the Pump Station

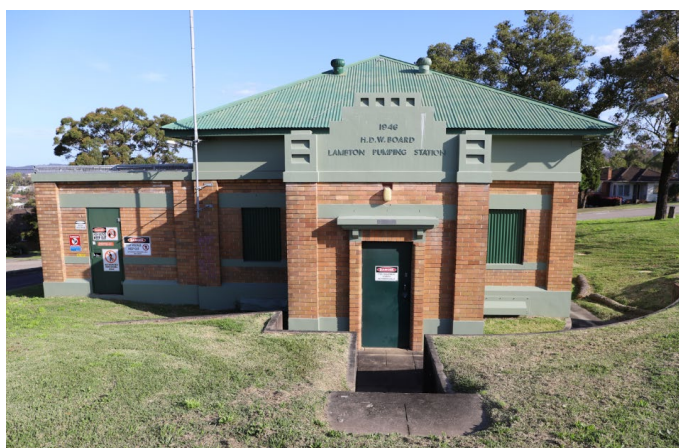
**Image 1:** View of the northern elevation of the building (centre frame), transformer bay (left of frame), retaining wall and recent roof

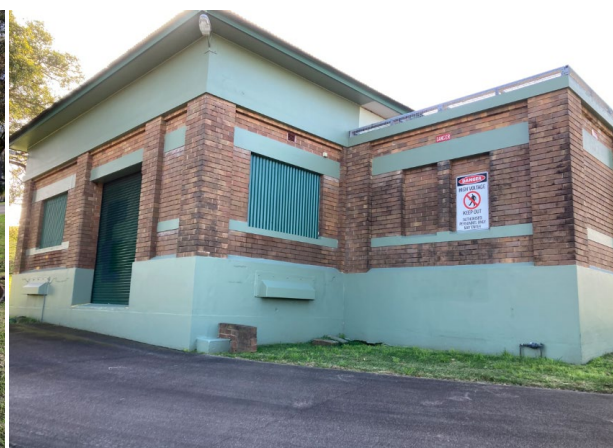
The windows to the principal building form have been covered over with green Colourbond sheeting or bricked in, with windows to the transformer bay are bricked in. Rainwater goods appear recent and have been painted red.

**Image 2:** Southern elevation of the building (left of frame) and transformer bay (right of frame) showing bricked up and covered windows, roller door, plinth, terracotta vent and recent lighting

- Assess and repair damage to ceiling within the portico.
- Remove graffiti from external walls.
- Assess and repair damage to brickwork including cracking and mortar loss. Structural assessment may be required to determine ongoing cause of cracking to plinth and brickwork.

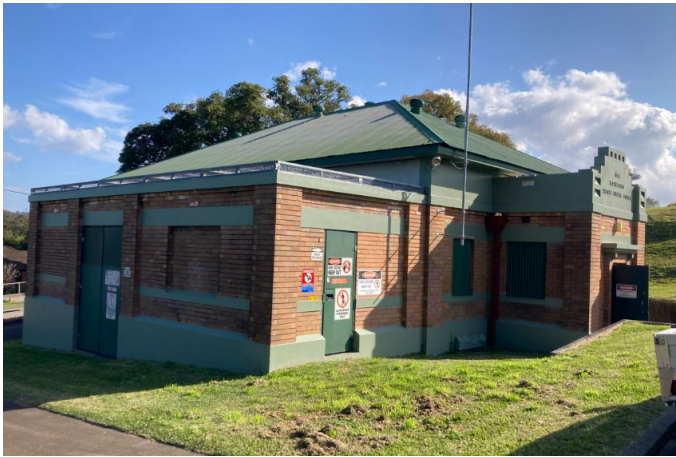
**Image 3:** View of the building facing southwest showing recent flush doors, recent roof and services

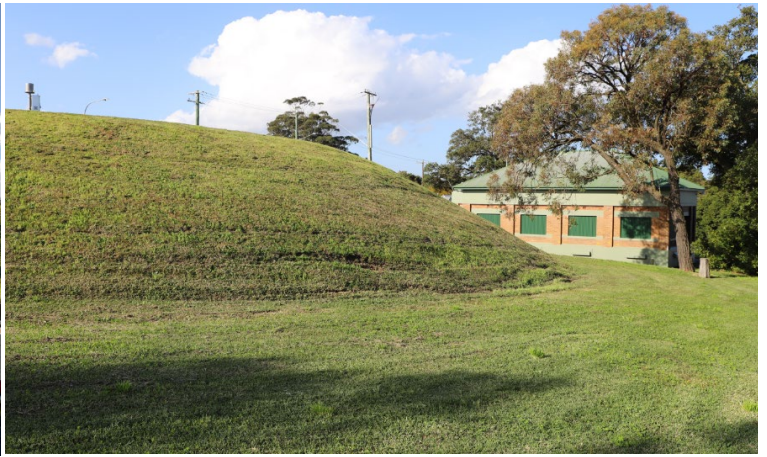
**Image 4:** Western elevation of the building showing reservoir at left of frame

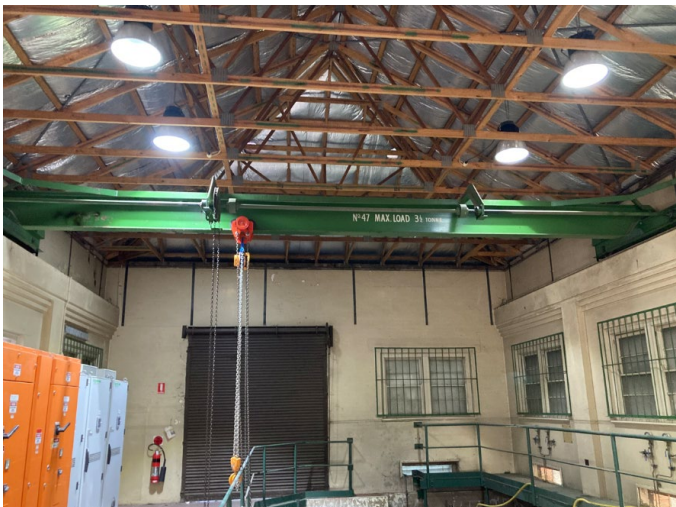
**Image 5:** Internal view within pumping station building showing roller door to southern façade, timber joinery to windows, timber roof structure (recent) and equipment

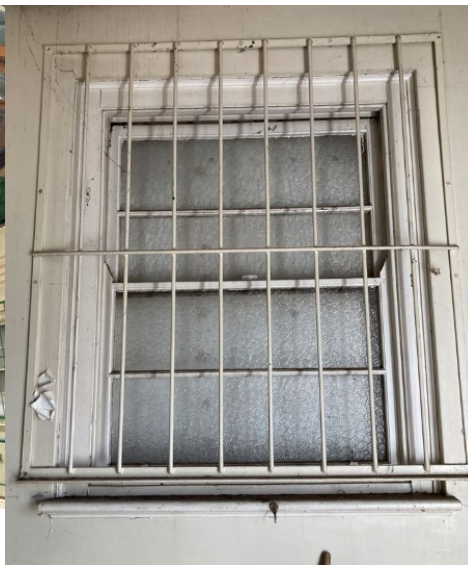
There is masonry detailing (stepping) to internal walls. Where windows are present (visible internally) they are timber framed double-hung sash windows with frosted glazing. The timber sills are decorative and hardware appears original.

**Image 6:** Detail view of original double-hung window with timber joinery

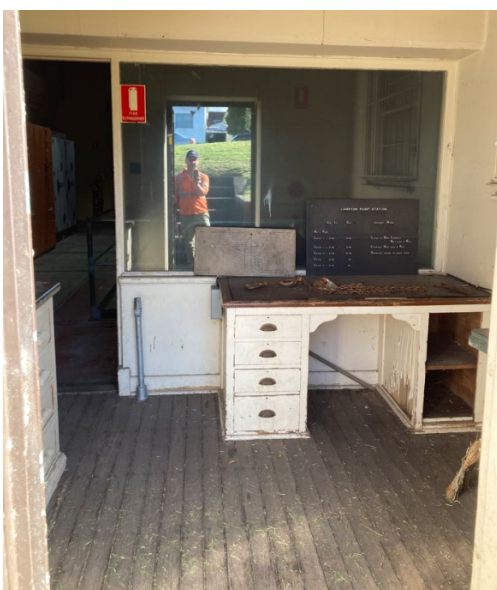
Internally, the building features original timber floorboards and room partitions of simple plasterboard and plain glazing to the portico entrance. Within the principal building form, the floors are concrete and no ceiling is present; the timber roof structure appears recent. Much of the internal equipment appears to have been replaced over time.

**Image 7:** Internal view within portico showing timber flooring, furniture and partitions of plasterboard and glazing

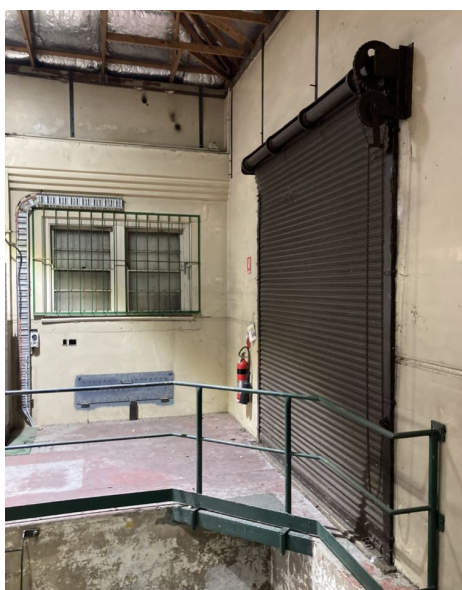
**Image 8:** Internal view within the building
