HUNTER WATERSECTION s170 REGISTER

Chichester Dam Office

ITEM DETAILS

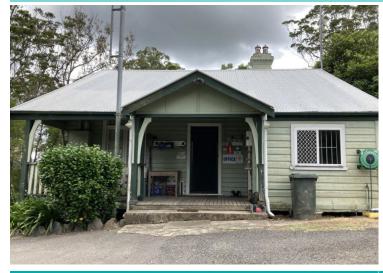
View of the principal (northern) façade of the building

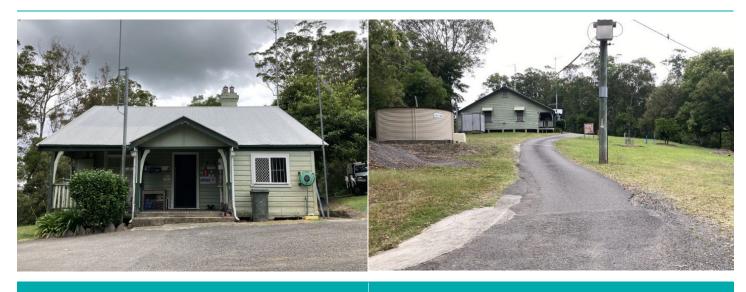
Image 1: Principal (northern) façade of the building

Image 2: Side (eastern) elevation of building and associated driveway. Piers are visible

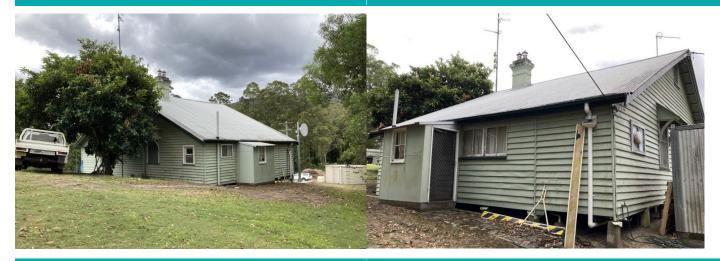
Image 3: Rear (southern) and side (western) elevations of building

Image 4: Rear (southern) façade of building with chimney visible

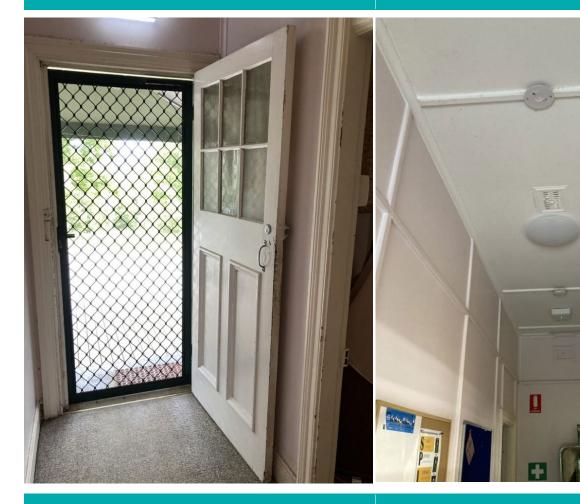
Image 8: Original joinery and ceiling and wall vents to hallway
